Single Survey

Property address	Foxholes, Lerags, Oban, PA34 4SE
-------------------------	---

Prepared by	DM Hall LLP
--------------------	-------------

Date of inspection	11th December 2025
---------------------------	--------------------

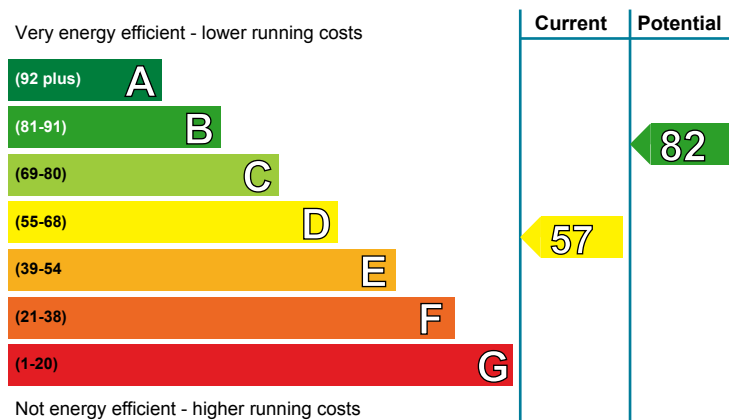
Energy Efficiency Rating

This graph shows the current efficiency of your home, taking into account both energy efficiency and fuel costs. The higher this rating, the lower your fuel bills are likely to be.

Your current rating is **band D (57)**. The average rating for EPCs in Scotland is **band D (61)**.

The potential rating shows the effect of undertaking all of the improvement measures listed within your recommendations report.

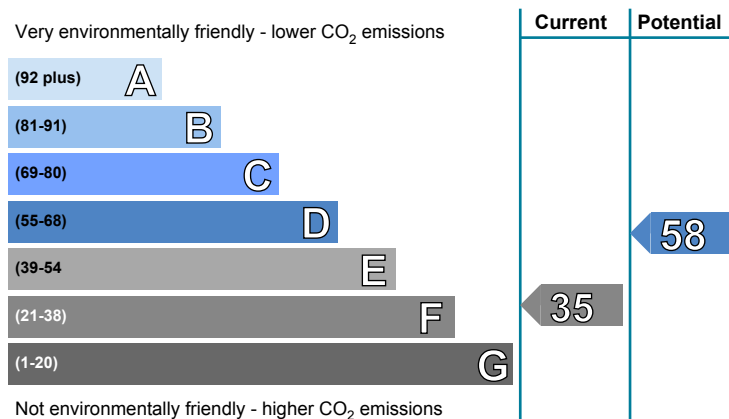
Environmental Impact (CO₂) Rating

This graph shows the effect of your home on the environment in terms of carbon dioxide (CO₂) emissions. The higher the rating, the less impact it has on the environment.
