# Home Report

# Single Survey

<b>Property address</b>	10 Pitmedden Road Aberdeen AB10 7BQ
<b>Customer</b>	[REDACTED]
<b>Customer address</b>	10 Pitmedden Road Aberdeen AB10 7BQ
<b>Prepared by</b>	Shepherd Chartered Surveyors
<b>Date of inspection</b>	01/06/2026

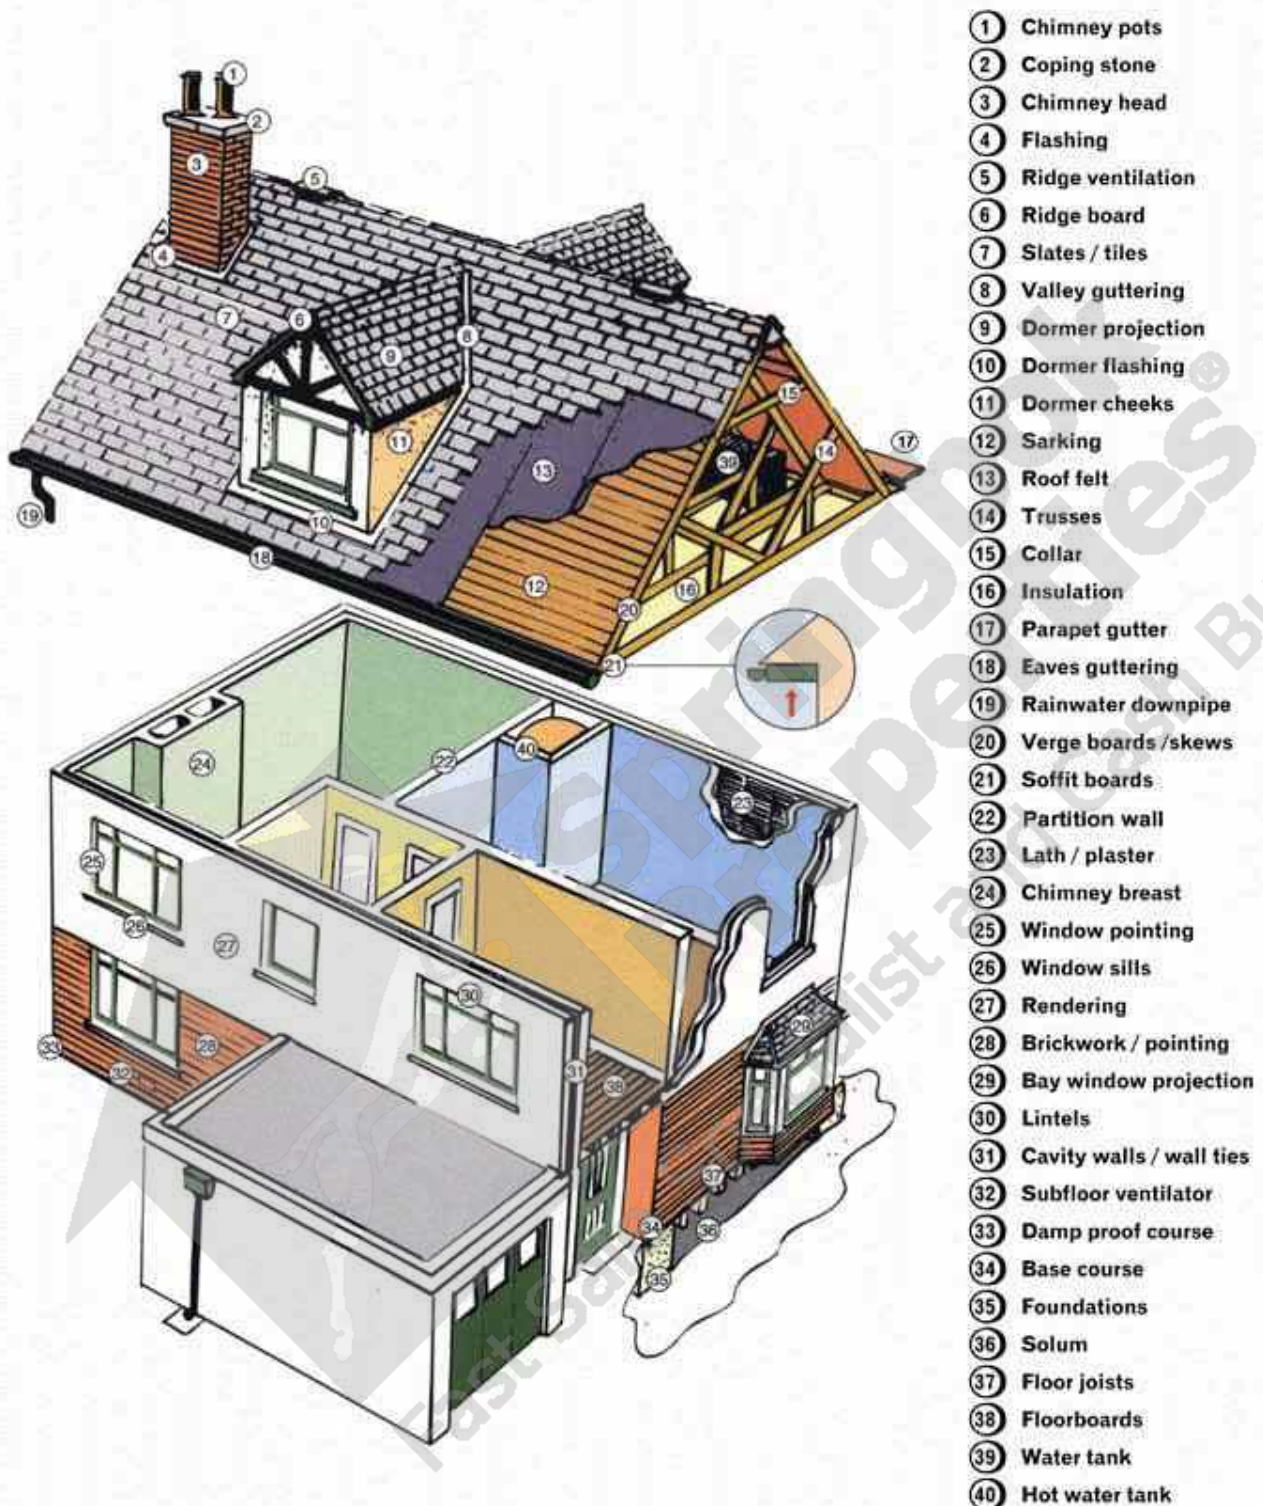
## Sectional Diagram showing elements of a typical house

Reference may be made in this report to some or all of the above component parts of the property. This diagram may assist you in locating and understanding these items.
