Home Report

Single Survey

Property address	3 Wylies Brae New Galloway Castle Douglas DG7 3RH
Customer	[REDACTED]
Customer address	3 Wylies Brae New Galloway Castle Douglas DG7 3RH
Prepared by	Shepherd Chartered Surveyors
Date of inspection	26/06/2026

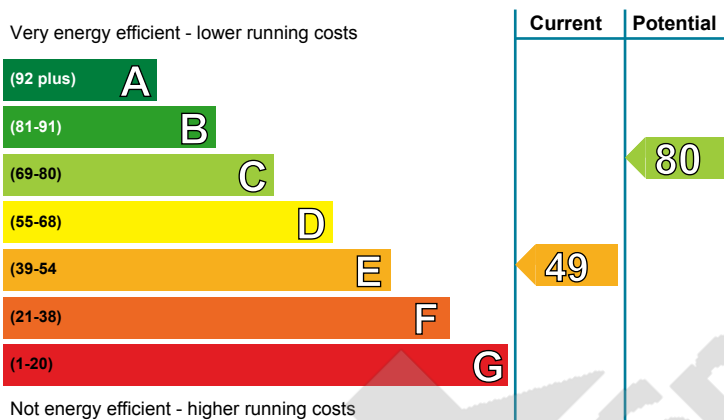
Energy Efficiency Rating

This graph shows the current efficiency of your home, taking into account both energy efficiency and fuel costs. The higher this rating, the lower your fuel bills are likely to be.

Your current rating is **band E (49)**. The average rating for EPCs in Scotland is **band D (61)**.

The potential rating shows the effect of undertaking all of the improvement measures listed within your recommendations report.

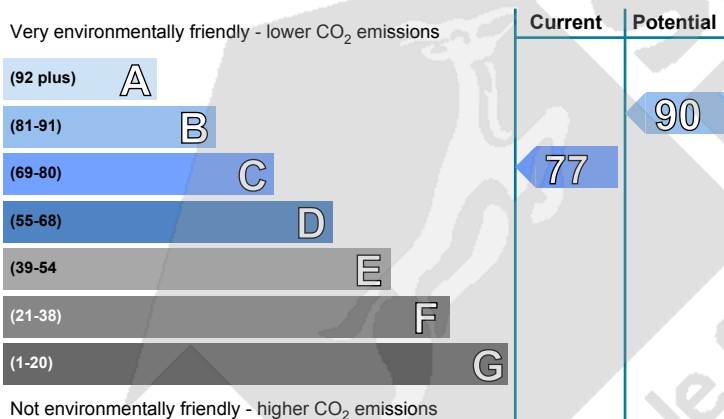
Environmental Impact (CO₂) Rating

This graph shows the effect of your home on the environment in terms of carbon dioxide (CO₂) emissions. The higher the rating, the less impact it has on the environment.
