# Home Report

# Scottish Single Survey

<b>Property address</b>	39 Haining Wynd Muirhead Glasgow G69 9FH
<b>Customer</b>	Dawn Walker
<b>Customer address</b>	39 Haining Wynd Muirhead Glasgow G69 9FH
<b>Prepared by</b>	Shepherd Chartered Surveyors
<b>Date of inspection</b>	06/07/2026

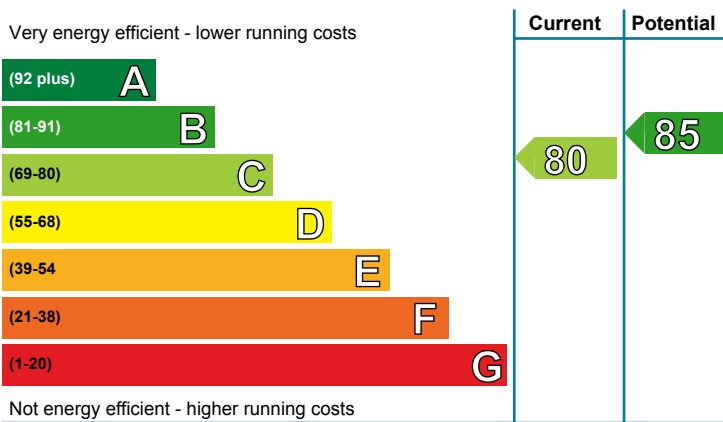
## Energy Efficiency Rating

This graph shows the current efficiency of your home, taking into account both energy efficiency and fuel costs. The higher this rating, the lower your fuel bills are likely to be.

Your current rating is **band C (80)**. The average rating for EPCs in Scotland is **band D (61)**.

The potential rating shows the effect of undertaking all of the improvement measures listed within your recommendations report.

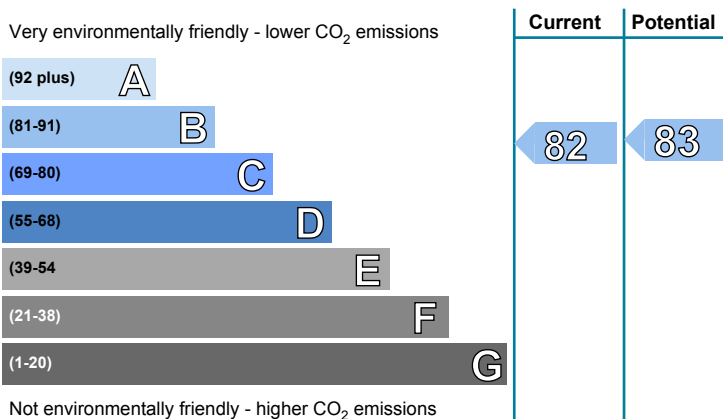
## Environmental Impact (CO<sub>2</sub>) Rating

This graph shows the effect of your home on the environment in terms of carbon dioxide (CO<sub>2</sub>) emissions. The higher the rating, the less impact it has on the environment.
