# Home Report

# Single Survey

<b>Property address</b>	19 Wintergreen Court East Kilbride Glasgow G74 4 UR
<b>Customer</b>	MAUREEN ROONEY
<b>Customer address</b>	19 Wintergreen Court East Kilbride Glasgow G74 4 UR
<b>Prepared by</b>	Shepherd Chartered Surveyors
<b>Date of inspection</b>	29/01/2026

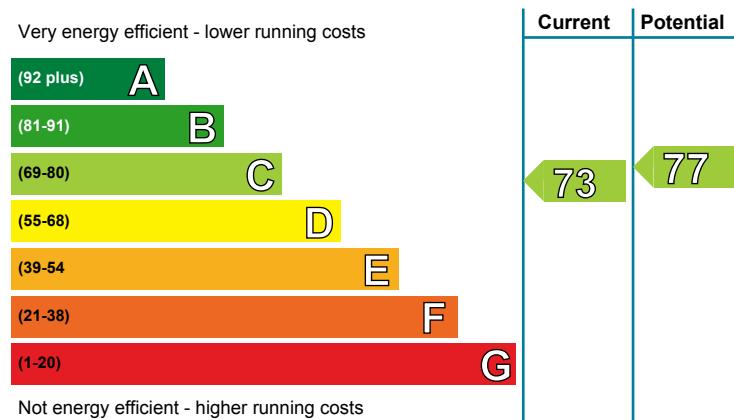
## Energy Efficiency Rating

This graph shows the current efficiency of your home, taking into account both energy efficiency and fuel costs. The higher this rating, the lower your fuel bills are likely to be.

Your current rating is **band C (73)**. The average rating for EPCs in Scotland is **band D (61)**.

The potential rating shows the effect of undertaking all of the improvement measures listed within your recommendations report.

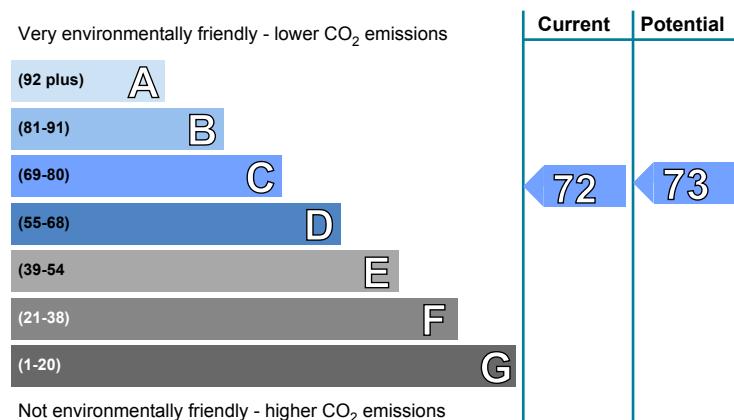
## Environmental Impact (CO<sub>2</sub>) Rating

This graph shows the effect of your home on the environment in terms of carbon dioxide (CO<sub>2</sub>) emissions. The higher the rating, the less impact it has on the environment.
