YOUR ONESURVEY
HOME REPORT

14b Gladstone Road
Saltcoats
KA21 5LD

SINGLE SURVEY

Single Survey

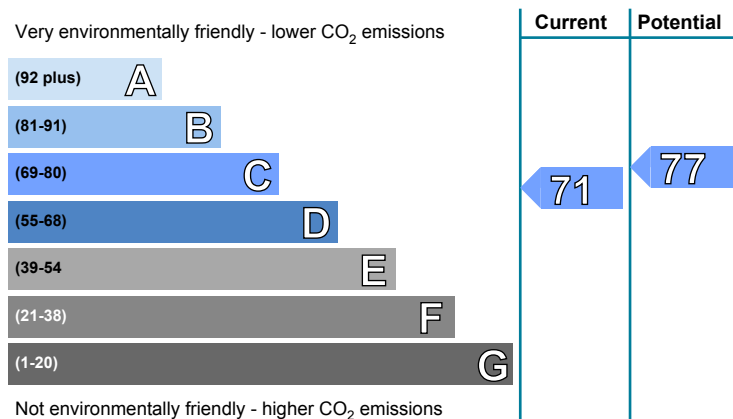
Environmental Impact (CO₂) Rating

This graph shows the effect of your home on the environment in terms of carbon dioxide (CO₂) emissions. The higher the rating, the less impact it has on the environment.
