YOUR ONESURVEY
HOME REPORT

65 Northfield Drive
Edinburgh
EH8 7RG

SINGLE SURVEY

Single Survey

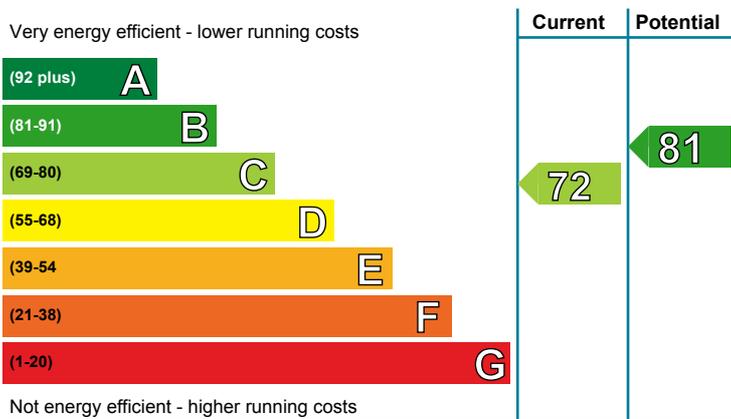
Energy Efficiency Rating

This graph shows the current efficiency of your home, taking into account both energy efficiency and fuel costs. The higher this rating, the lower your fuel bills are likely to be.

Your current rating is **band C (72)**. The average rating for EPCs in Scotland is **band D (61)**.

The potential rating shows the effect of undertaking all of the improvement measures listed within your recommendations report.

Estimated energy costs for your home for 3 years*	£2,823	See your recommendations report for more information
Over 3 years you could save*	£504
