# Home Report

1 Gagiebank  
Broughty Ferry Dundee DD5 3PT

# Single Survey

<b>Property Address</b>	1 Gagiebank Broughty Ferry Dundee DD5 3PT
<b>Customer</b>	Scott Whittet & Lindsay Whittet
<b>Prepared by</b>	Graham + Sibbald Property Consultants Limited
<b>Date of Inspection</b>	07/04/2026

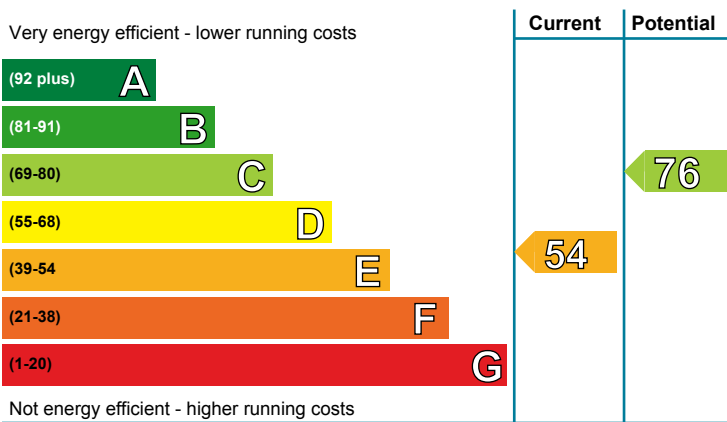
## Energy Efficiency Rating

This graph shows the current efficiency of your home, taking into account both energy efficiency and fuel costs. The higher this rating, the lower your fuel bills are likely to be.

Your current rating is **band E (54)**. The average rating for EPCs in Scotland is **band D (61)**.

The potential rating shows the effect of undertaking all of the improvement measures listed within your recommendations report.

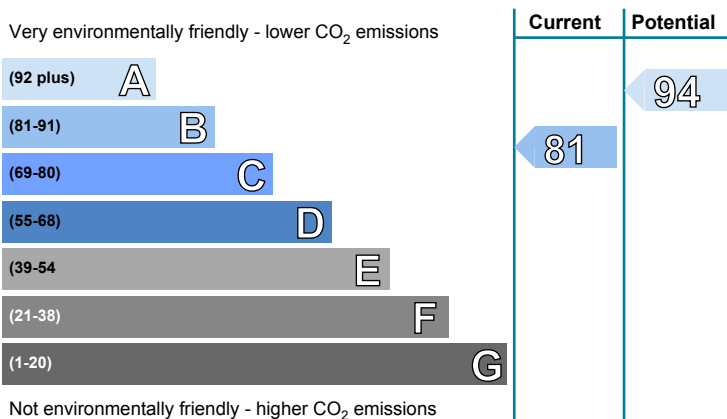
## Environmental Impact (CO<sub>2</sub>) Rating

This graph shows the effect of your home on the environment in terms of carbon dioxide (CO<sub>2</sub>) emissions. The higher the rating, the less impact it has on the environment.
