# Home Report

Free Church Manse,  
Kilmuir,  
PORTREE,  
IV51 9UB

# Single Survey

## Survey Report on:

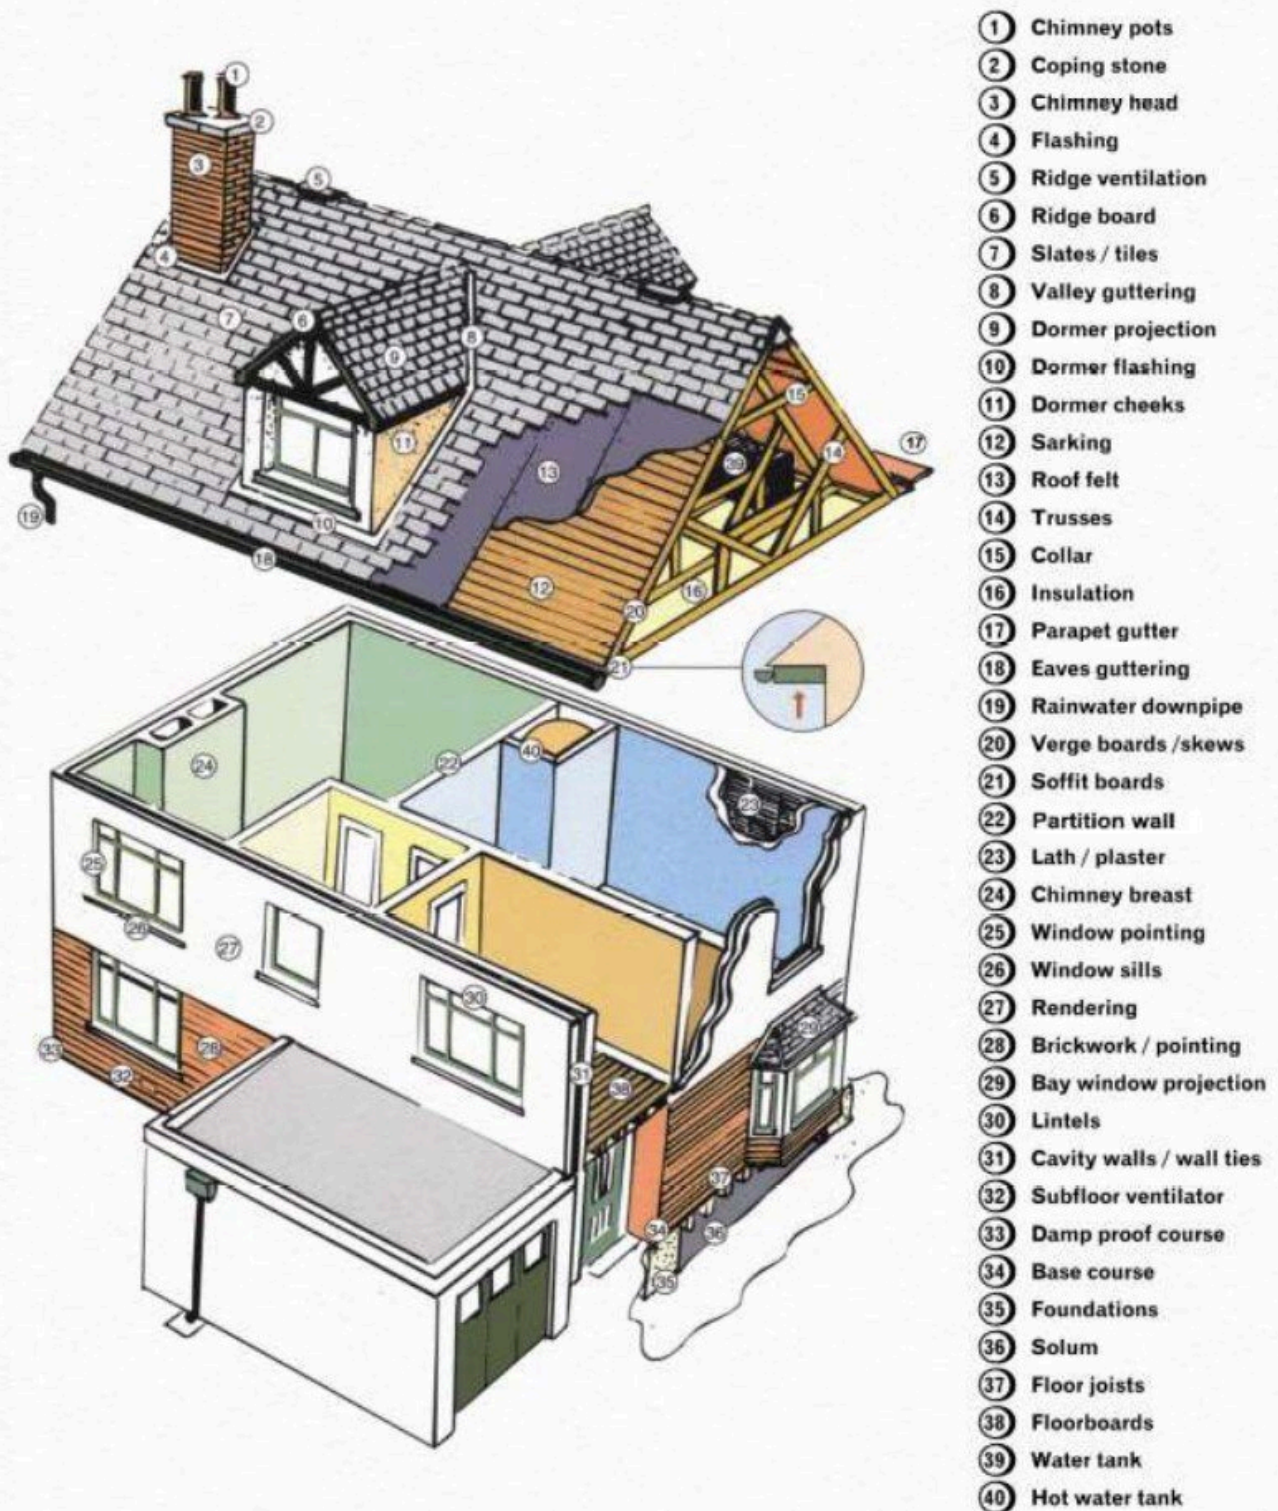
## Sectional Diagram showing elements of a typical house

Reference may be made in this report to some or all of the above component parts of the property. This diagram may assist you in locating and understanding these items.
