# PROPERTY DOCUMENTS

2 Walden Road, Sheffield, S2 3PJ

## HomeCheck Property Review

A practical pre-sale review of the property's visible condition,  
with cost guidance for likely repairs and maintenance

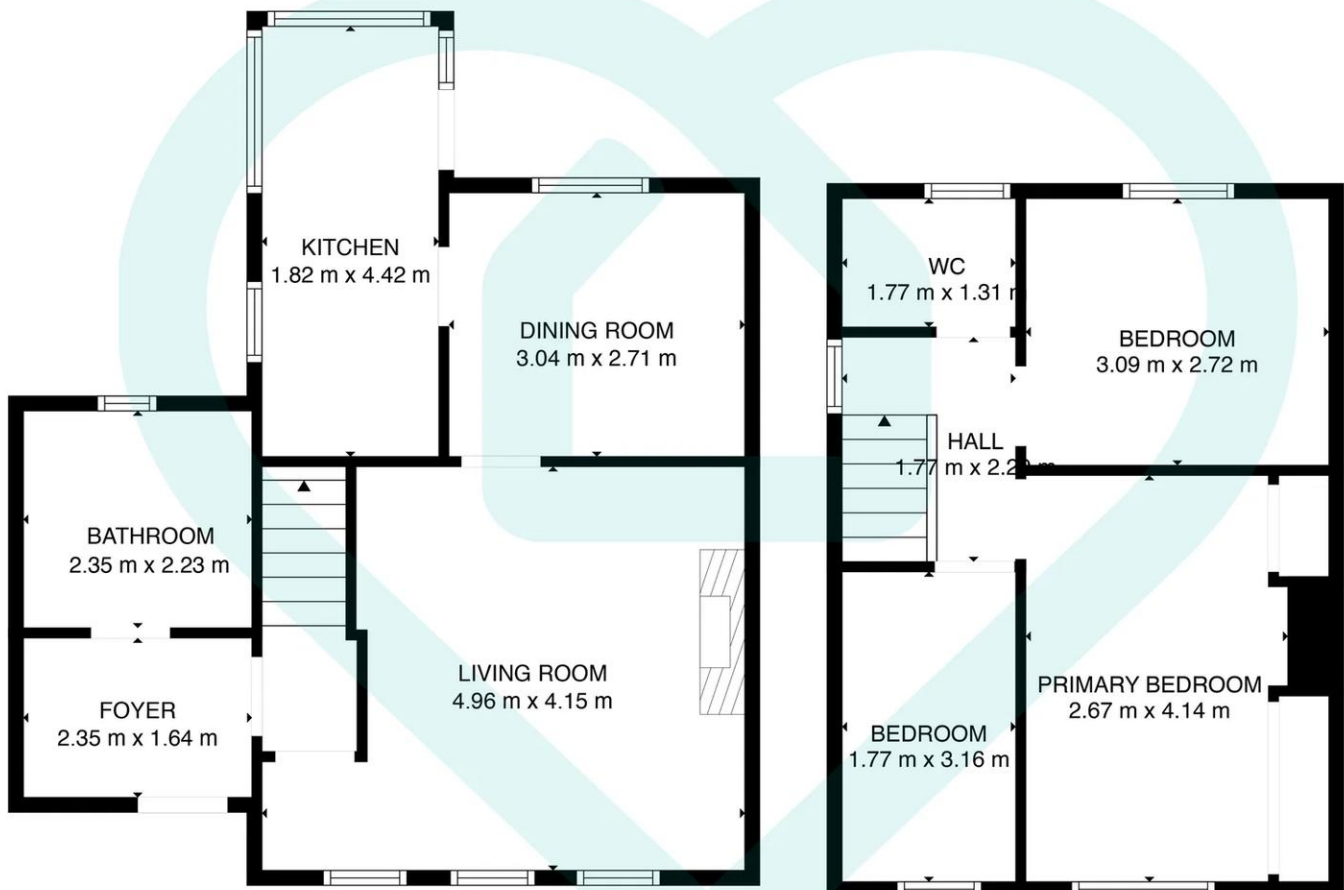
**TOTAL: 82 m<sup>2</sup>**  
GROUND FLOOR: 47 m<sup>2</sup>, FIRST FLOOR: 35 m<sup>2</sup>  
WALLS: 8 m<sup>2</sup>

| Floorplan | 3 |
