Home Report

Scottish Single Survey

Single Survey

Property address	48 Sophia Crescent Irvine KA12 9BN
Customer	[REDACTED]
Customer address	48 Sophia Crescent Irvine KA12 9BN
Prepared by	Shepherd Chartered Surveyors
Date of inspection	30/01/2026

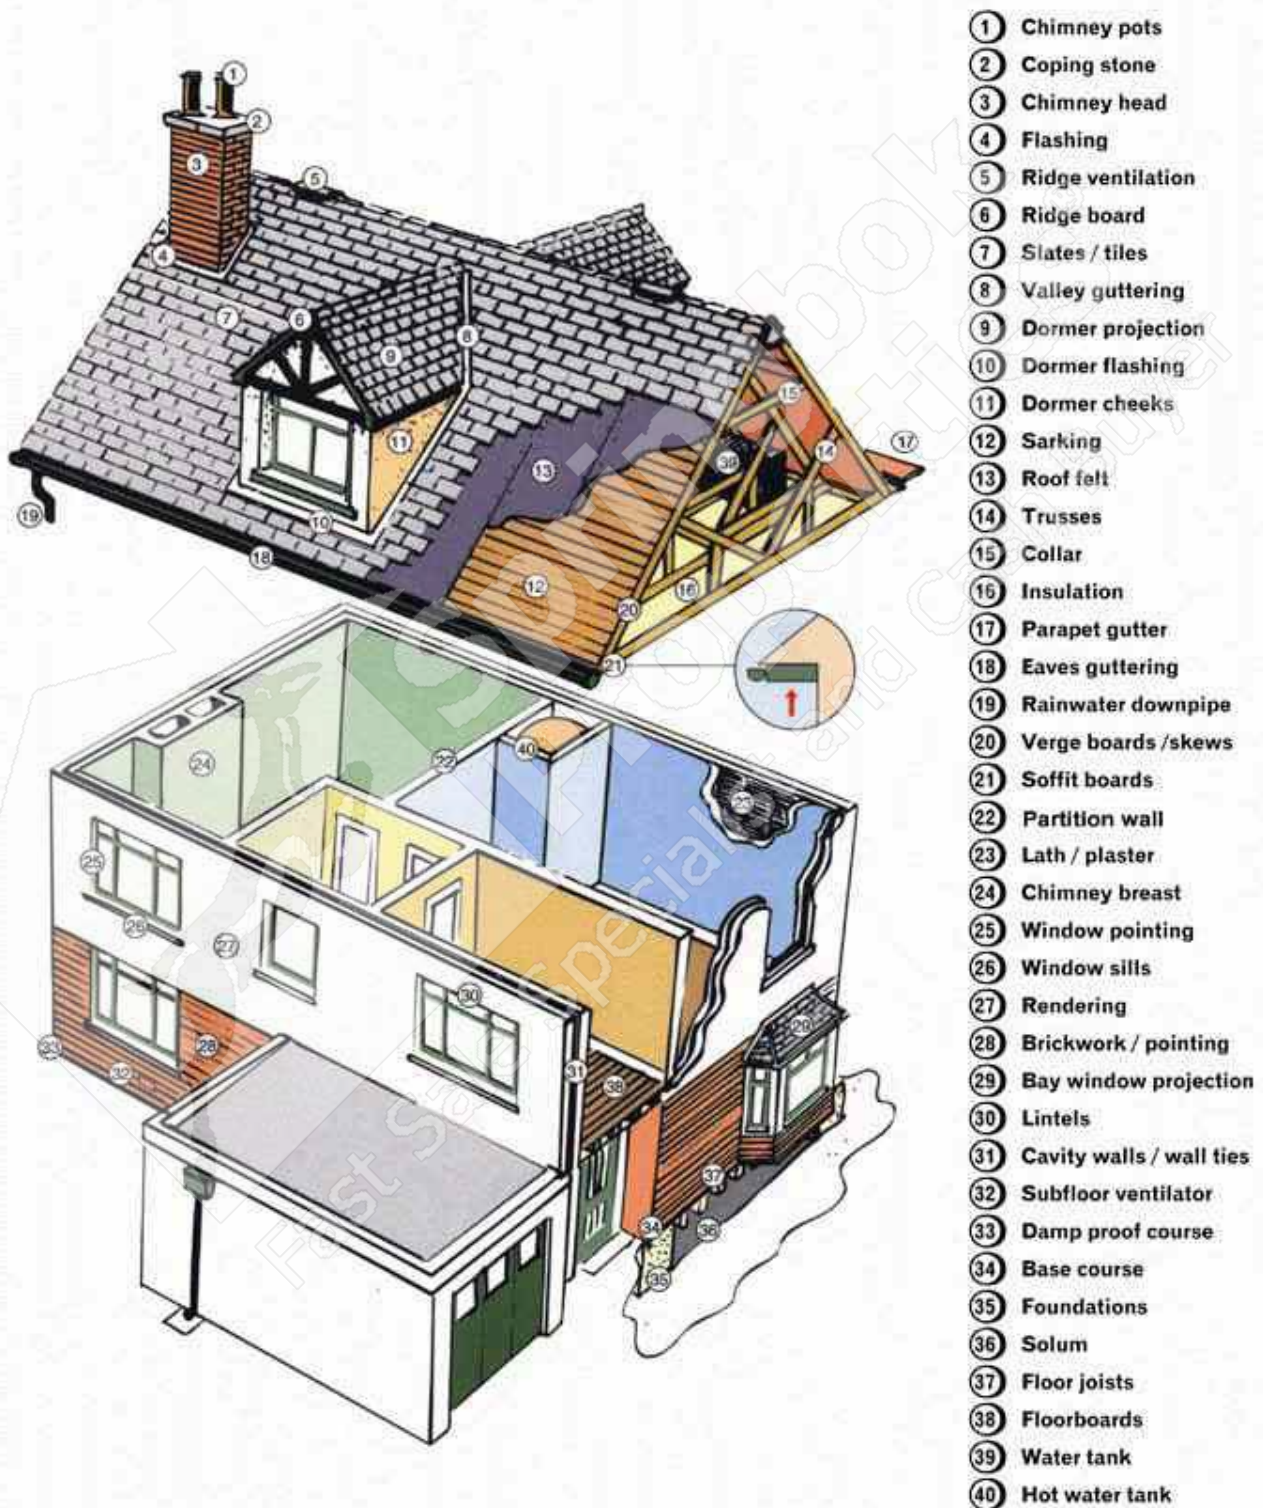
Sectional Diagram showing elements of a typical house

Reference may be made in this report to some or all of the above component parts of the property. This diagram may assist you in locating and understanding these items.
