# Home Report

2 Inchcape Road  
Arbroath DD11 2DF

Date of Valuation: 13/05/2026

# Single Survey

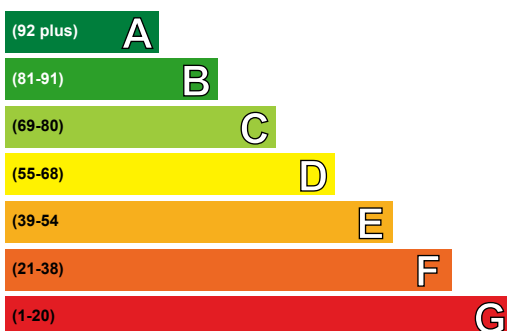
\* based upon the cost of energy for heating, hot water, lighting and ventilation, calculated using standard assumptions

Very energy efficient - lower running costs

Not energy efficient - higher running costs

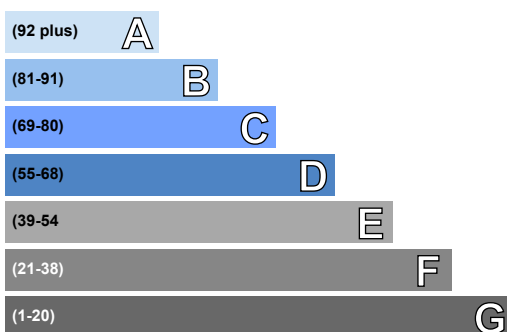
The potential rating shows the effect of undertaking all of the improvement measures listed within your recommendations report.

Very environmentally friendly - lower CO<sub>2</sub> emissions

Not environmentally friendly - higher CO<sub>2</sub> emissions
