Home Report

Single Survey

| Property address | 24 Southesk Street Brechin DD9 6AG |
| Prepared by | Shepherd Chartered Surveyors |

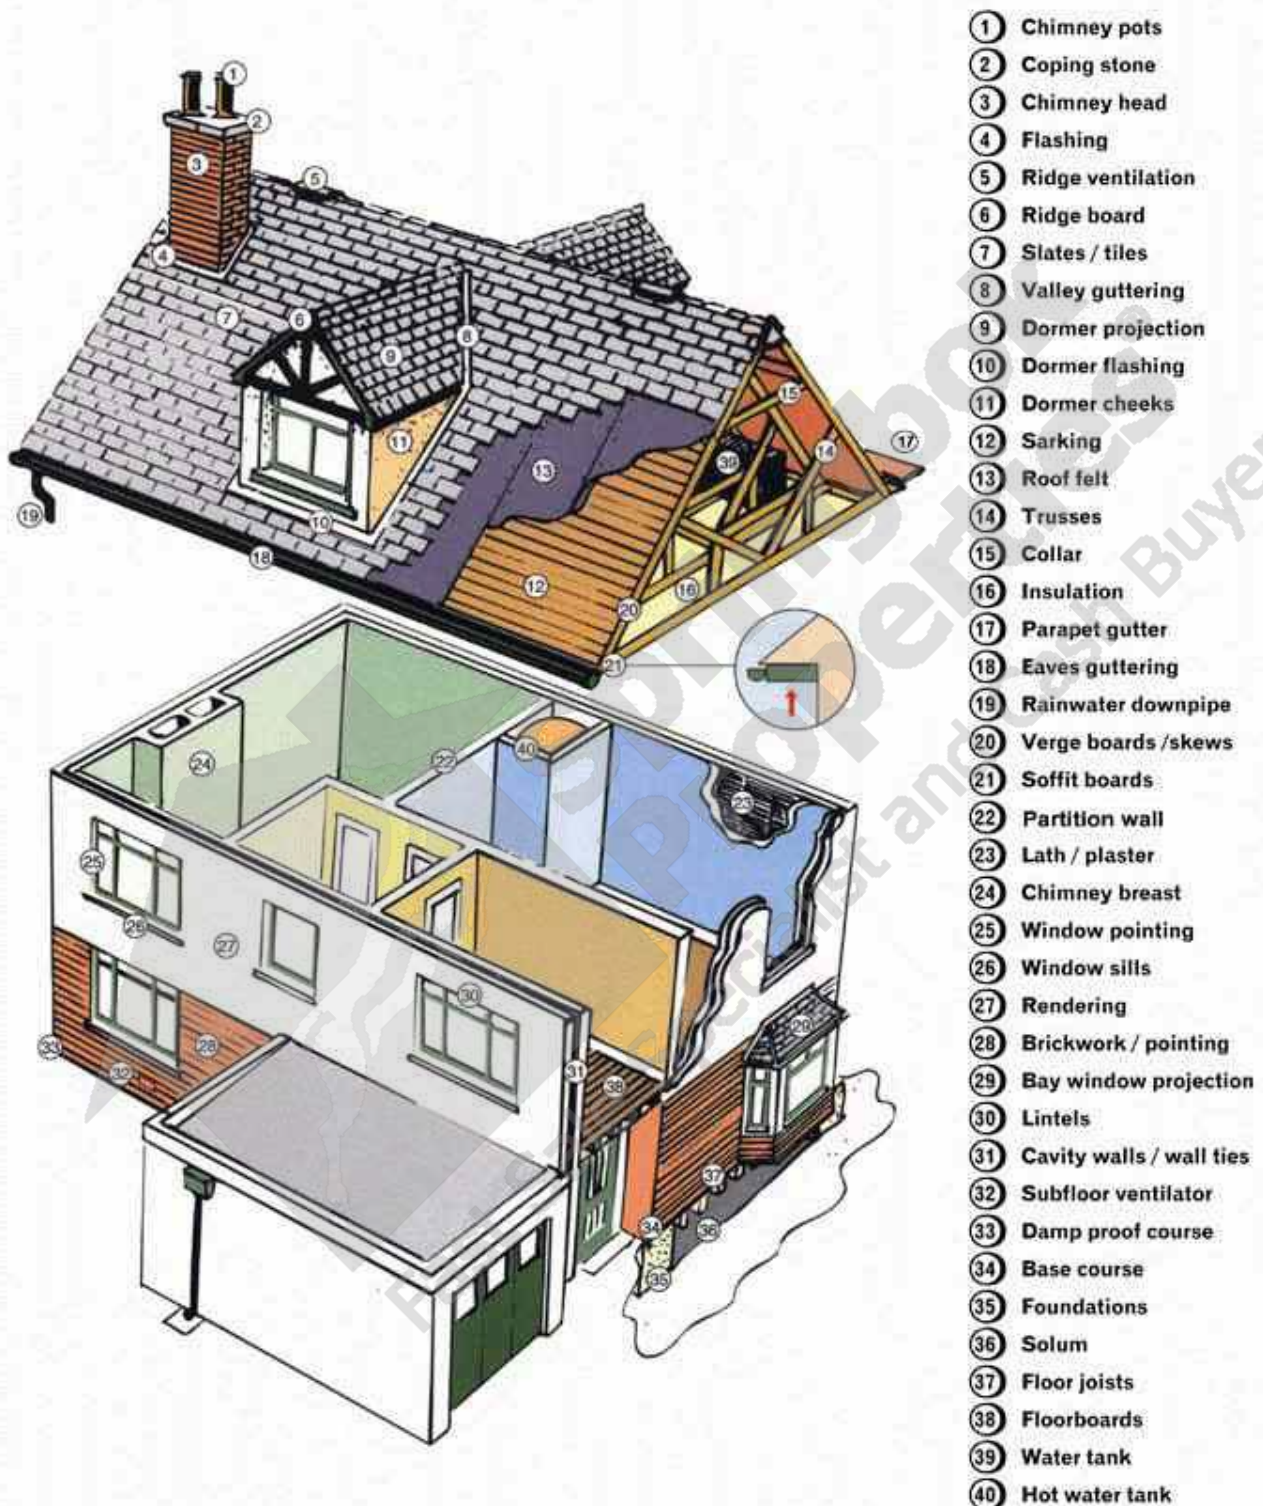
Sectional Diagram showing elements of a typical house

Reference may be made in this report to some or all of the above component parts of the property. This diagram may assist you in locating and understanding these items.
