# Home Report

# Single Survey

survey report on:

| Property address | 9 Lammermuir Road<br>Kilmarnock<br>KA1 3TU |

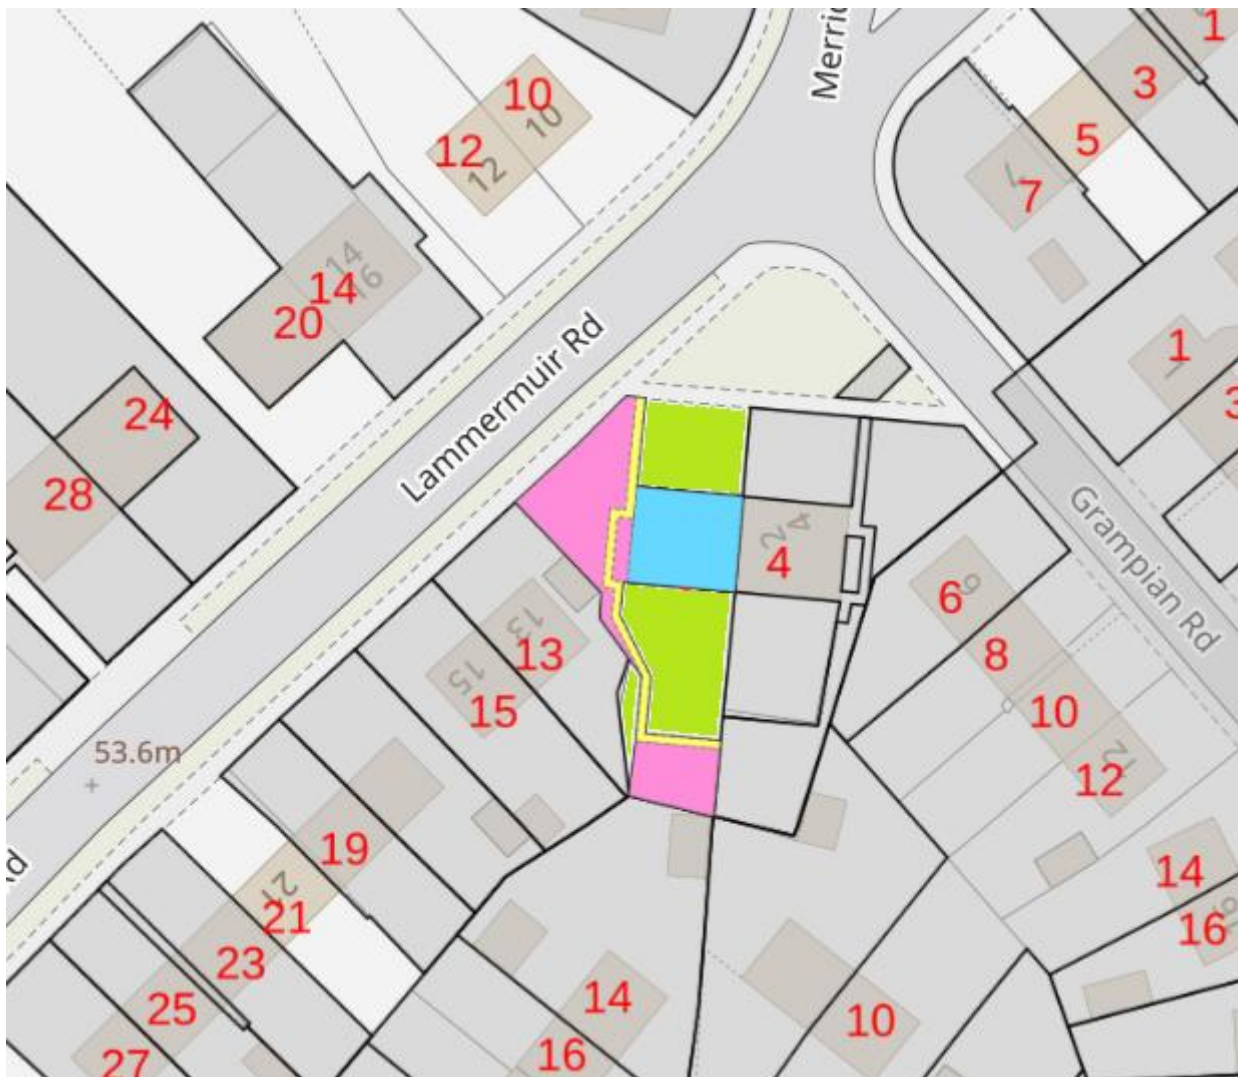
Title plan for 11 Lammermuir Rd showing their garden in pink and shared common access path with No 9 in yellow. Flats 9 & 11 are shown in blue, with garden of Council house shown in green
