# Home Report

2 Kinghorne Terrace  
Dundee DD3 6HX

# Single Survey

<b>Property Address</b>	2 Kinghorne Terrace Dundee DD3 6HX
<b>Customer</b>	Nora Hanson
<b>Prepared by</b>	Graham + Sibbald Property Consultants Limited
<b>Date of Inspection</b>	09/03/2026

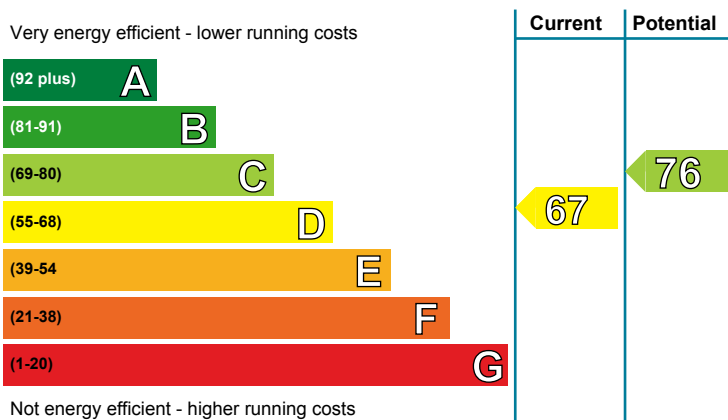
## Energy Efficiency Rating

This graph shows the current efficiency of your home, taking into account both energy efficiency and fuel costs. The higher this rating, the lower your fuel bills are likely to be.

Your current rating is **band D (67)**. The average rating for EPCs in Scotland is **band D (61)**.

The potential rating shows the effect of undertaking all of the improvement measures listed within your recommendations report.

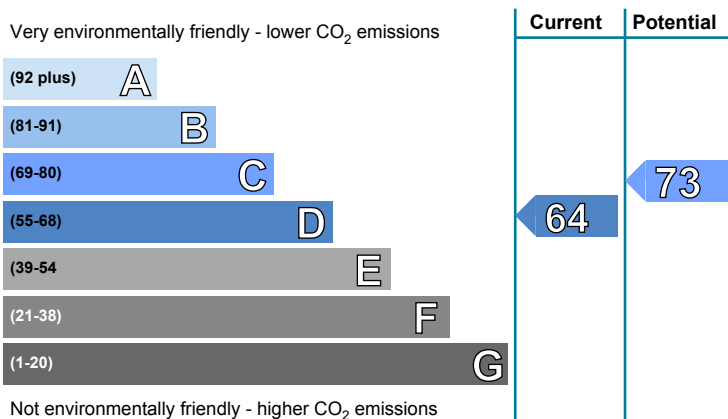
## Environmental Impact (CO<sub>2</sub>) Rating

This graph shows the effect of your home on the environment in terms of carbon dioxide (CO<sub>2</sub>) emissions. The higher the rating, the less impact it has on the environment.
