Single Survey

Survey report on:

Property Address	3 Balmain Cottages Fettercairn Laurencekirk AB30 1DA
Customer	Robert Brown
Prepared by	Graham + Sibbald Property Consultants Limited
Date of Inspection	07/04/2026

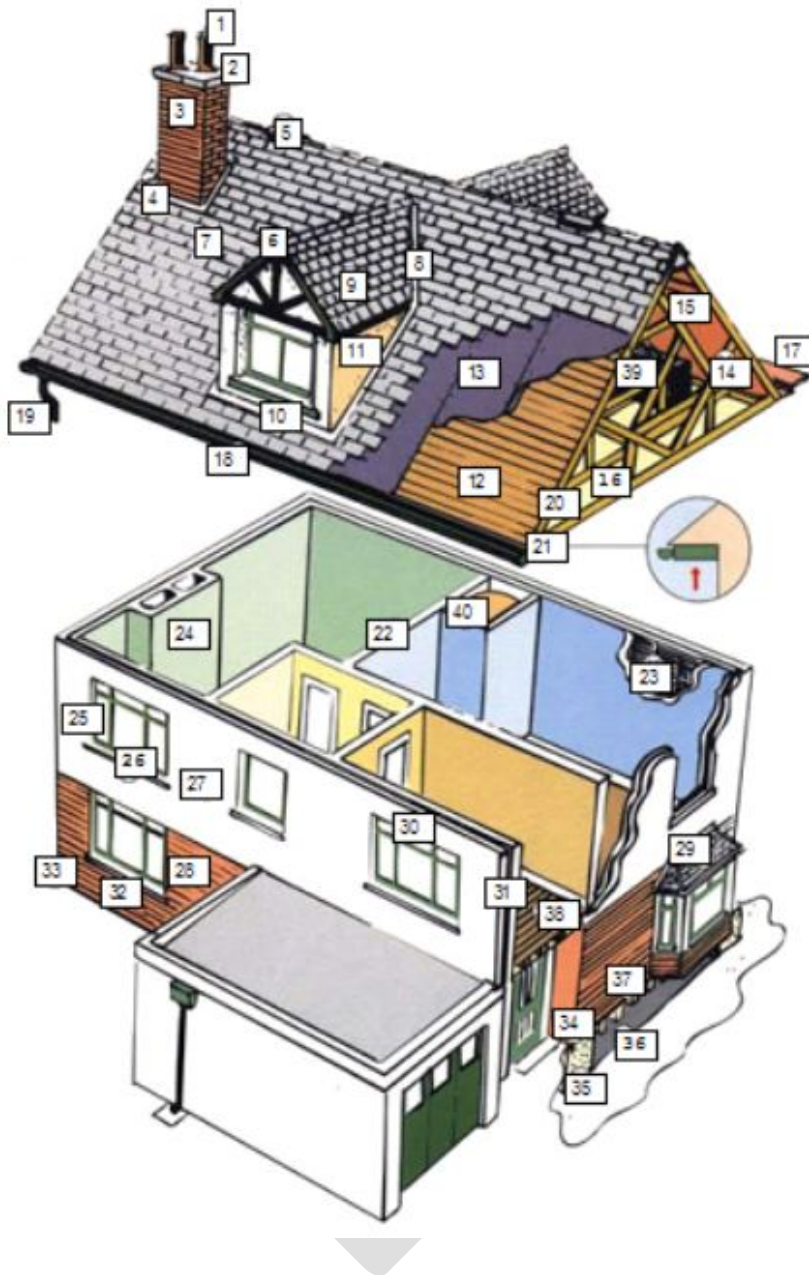
Sectional diagram showing elements of a typical house

1	Chimney pots
2	Coping stone
3	Chimney head
4	Flashing
5	Ridge ventilation
6	Ridge board
7	Slates / tiles
8	Valley guttering
9	Dormer projection
10	Dormer flashing
11	Dormer cheeks
12	Sarking
13	Roof felt
14	Trusses
15	Collar
16	Insulation
17	Parapet gutter
18	Eaves guttering
19	Rainwater downpipe
20	Verge boards / skews
21	Soffit boards
22	Partition wall
23	Lath / plaster
24	Chimney breast
25	Window pointing
26	Window sills
27	Rendering
28	Brickwork / pointing
29	Bay window projection
30	Lintels
31	Cavity walls / wall ties
32	Subfloor ventilator
33	Damp proof course
34	Base course
35	Foundations
36	Solum
37	Floor joists
38	Floorboards
39	Water tank
40	Hot water tank

Reference may be made in this report to some or all of the above component parts of the property. This diagram may assist you in locating and understanding these items.
