Home Report

Single Survey

Property address	58 Alwyn Drive East Kilbride Glasgow G74 4RL
Customer	Jean Armstrong
Customer address	58 Alwyn Drive East Kilbride Glasgow G74 4RL
Prepared by	Shepherd Chartered Surveyors
Date of inspection	09/04/2026

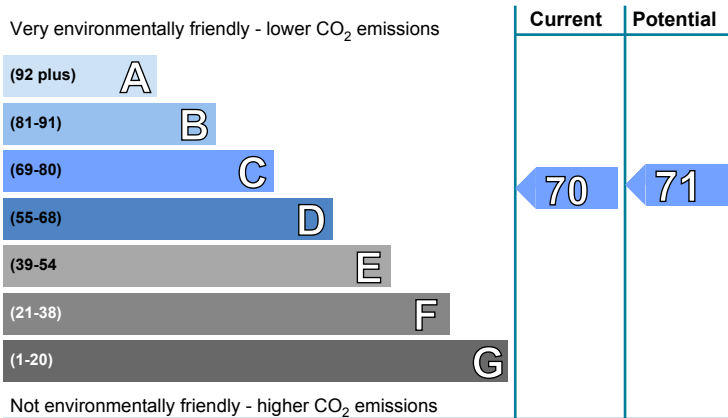
Environmental Impact (CO₂) Rating

This graph shows the effect of your home on the environment in terms of carbon dioxide (CO₂) emissions. The higher the rating, the less impact it has on the environment.
