Home Report

Single Survey

Property address	27 Fenton Place East Kilbride Glasgow G75 9FL
-------------------------	--

Prepared by	Shepherd Chartered Surveyors
--------------------	------------------------------

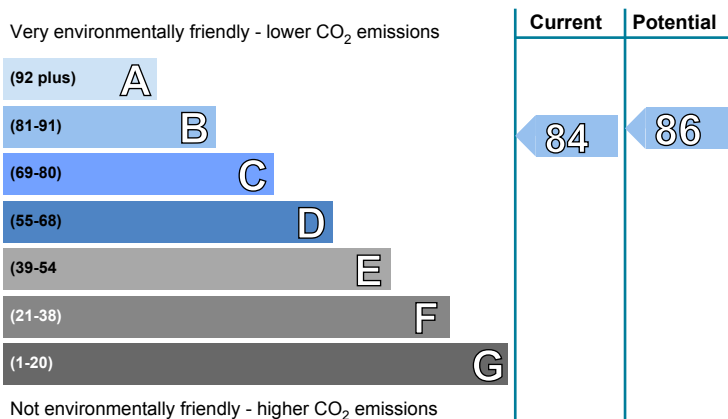
Environmental Impact (CO₂) Rating

This graph shows the effect of your home on the environment in terms of carbon dioxide (CO₂) emissions. The higher the rating, the less impact it has on the environment.
