# Home Report

# Scottish Single Survey

| Property address | 1f4<br>29 Springvalley Terrace<br>Edinburgh<br>EH10 4PZ |
| Prepared by | Shepherd Chartered Surveyors |

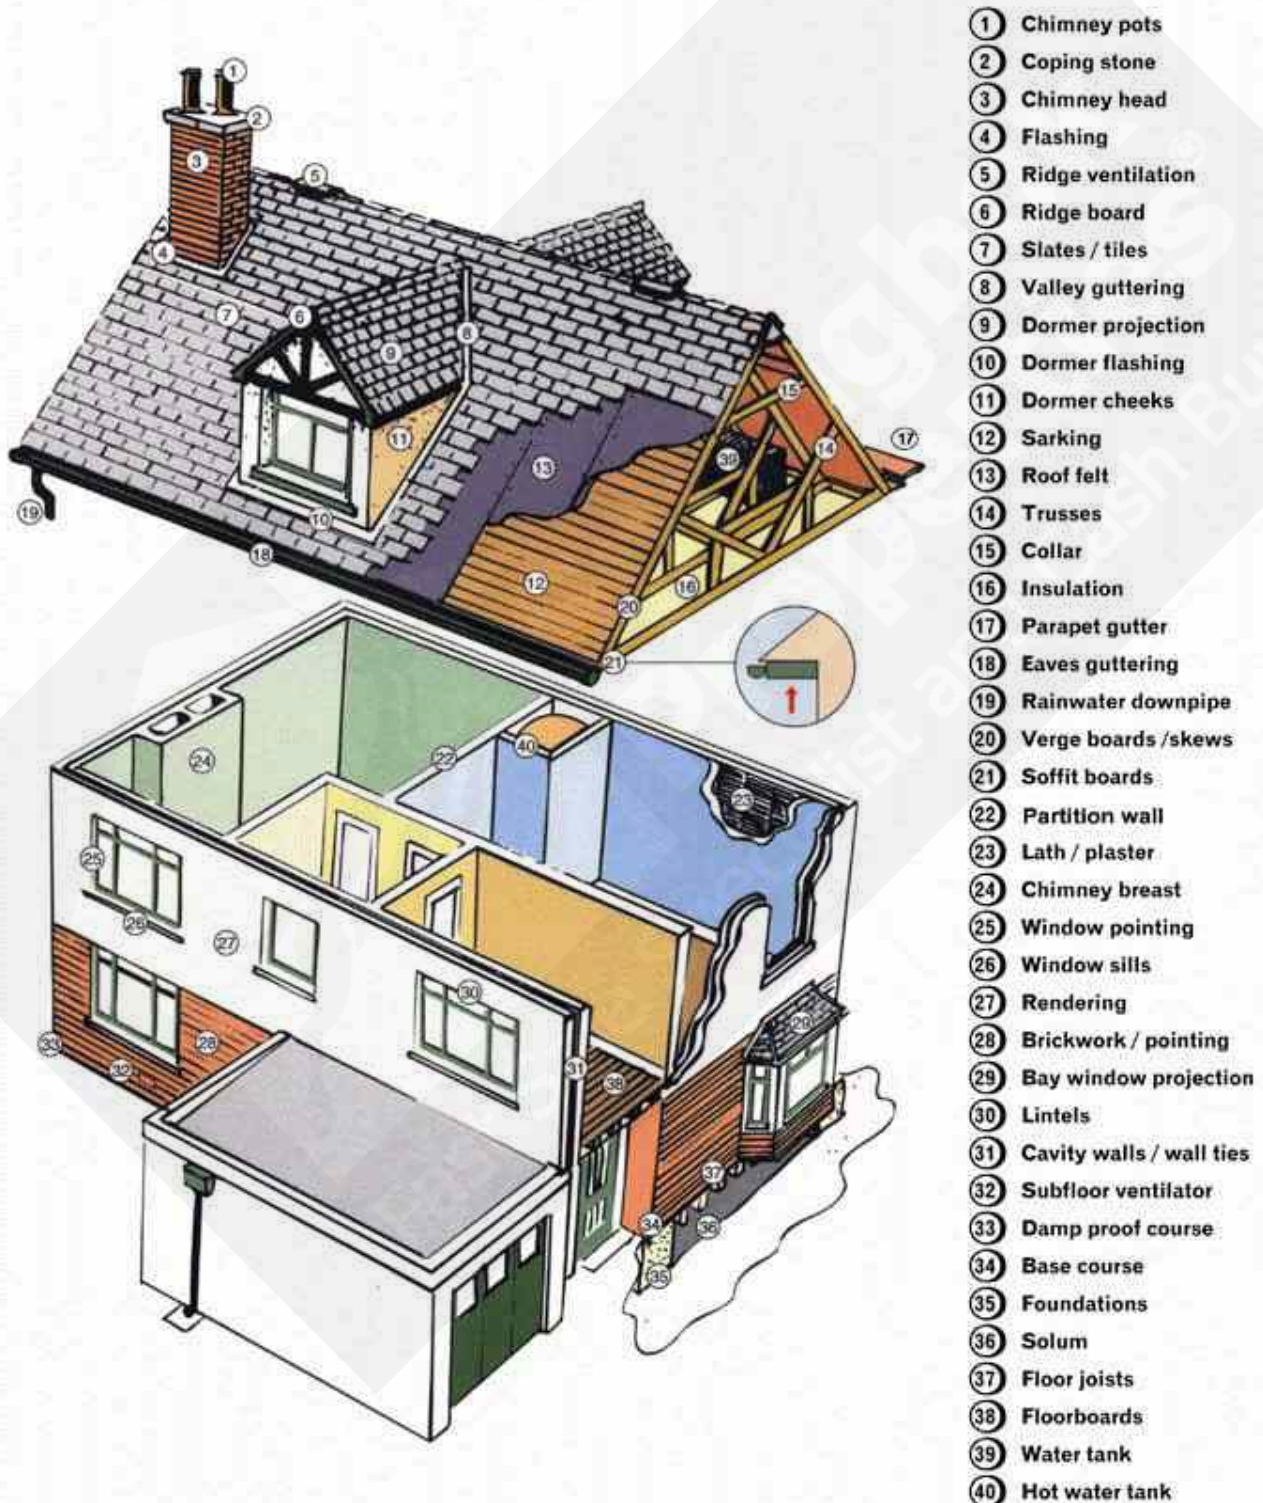
## Sectional Diagram showing elements of a typical house

Reference may be made in this report to some or all of the above component parts of the property. This diagram may assist you in locating and understanding these items.

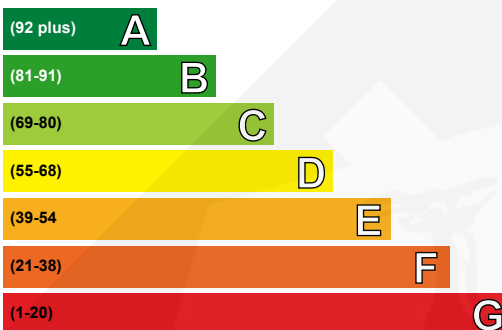
Very energy efficient - lower running costs

| Current | Potential |
|---|---|
| 74 | 79 |

Not energy efficient - higher running costs

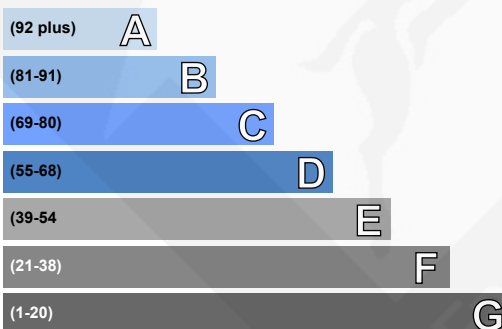
Very environmentally friendly - lower CO<sub>2</sub> emissions

| Current | Potential |
|---|---|
| 78 | 84 |
