9 Pilmuir Road West,
Forres,
IV36 2HN

Home Report

Single Survey

Survey Report on:

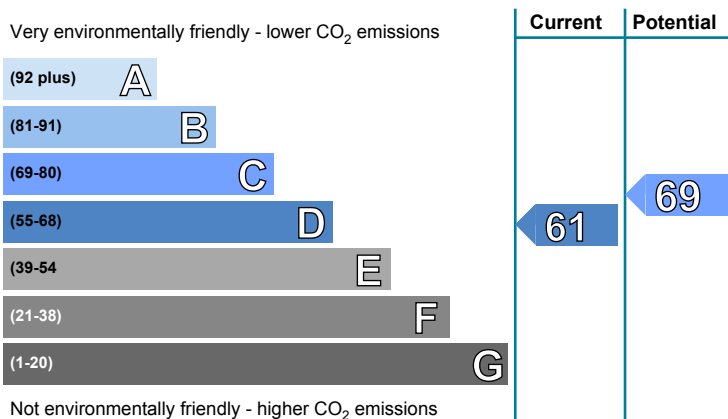
Environmental Impact (CO₂) Rating

This graph shows the effect of your home on the environment in terms of carbon dioxide (CO₂) emissions. The higher the rating, the less impact it has on the environment.
