# Home Report

Esset Pines

# **Single Survey and Mortgage Valuation Report**

<b>Date of inspection</b>	10th June 2026
---------------------------	----------------

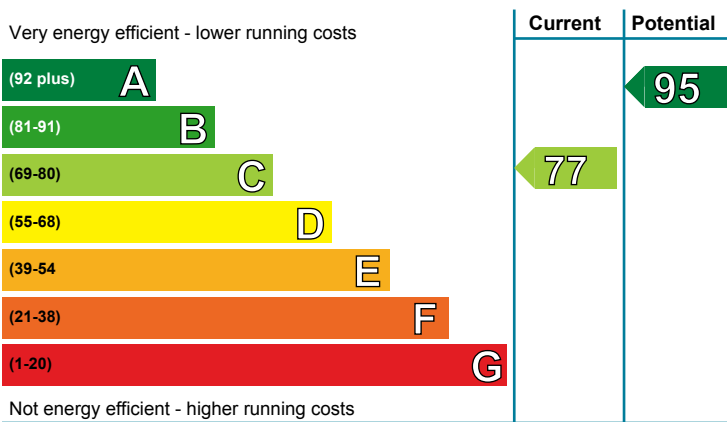
## Energy Efficiency Rating

This graph shows the current efficiency of your home, taking into account both energy efficiency and fuel costs. The higher this rating, the lower your fuel bills are likely to be.

Your current rating is **band C (77)**. The average rating for EPCs in Scotland is **band D (61)**.

The potential rating shows the effect of undertaking all of the improvement measures listed within your recommendations report.
