4 Cornton Cottages,
Argaty,
Doune,
FK16 6EJ

Home Report

Single Survey

Property Address	4 Cornton Cottages, Argaty, Doune, FK16 6EJ
Reference	1413778
Customer Name	Moira Walker
Date of Inspection	5th February 2026
Surveyor's name, qualifications and office	Gordon McCulloch DipSurv. MRICS DM Hall LLP Chartered Surveyors Suite 2C 1 Pitt Terrace Stirling FK8 2EZ Tel: 01786 475785 email: stirlingresidential@dmhall.co.uk
Prepared By	DM Hall LLP

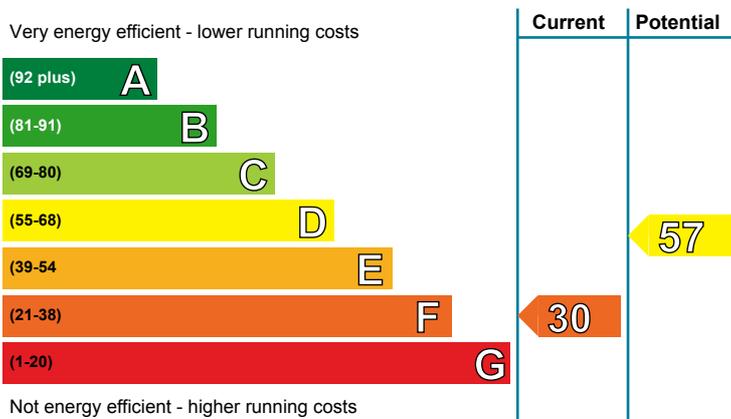
Energy Efficiency Rating

This graph shows the current efficiency of your home, taking into account both energy efficiency and fuel costs. The higher this rating, the lower your fuel bills are likely to be.

Your current rating is **band F (30)**. The average rating for EPCs in Scotland is **band D (61)**.

The potential rating shows the effect of undertaking all of the improvement measures listed within your recommendations report.

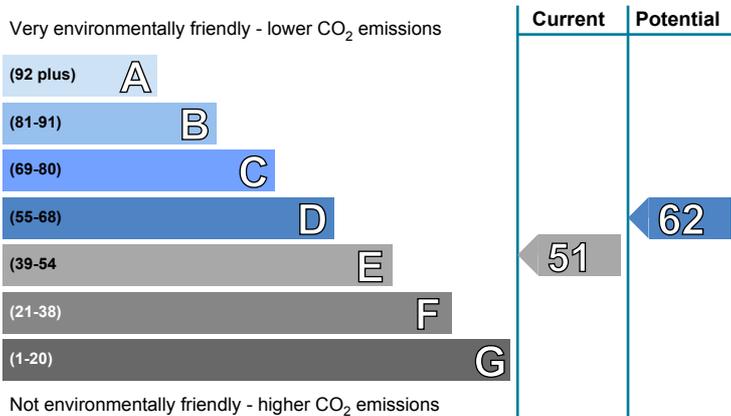
Environmental Impact (CO₂) Rating

This graph shows the effect of your home on the environment in terms of carbon dioxide (CO₂) emissions. The higher the rating, the less impact it has on the environment.
