**GADIE BANK COTTAGE
GAUDIEBANK
PREMNAY
INSCH
AB52 6PL**

HOME REPORT

SINGLE SURVEY

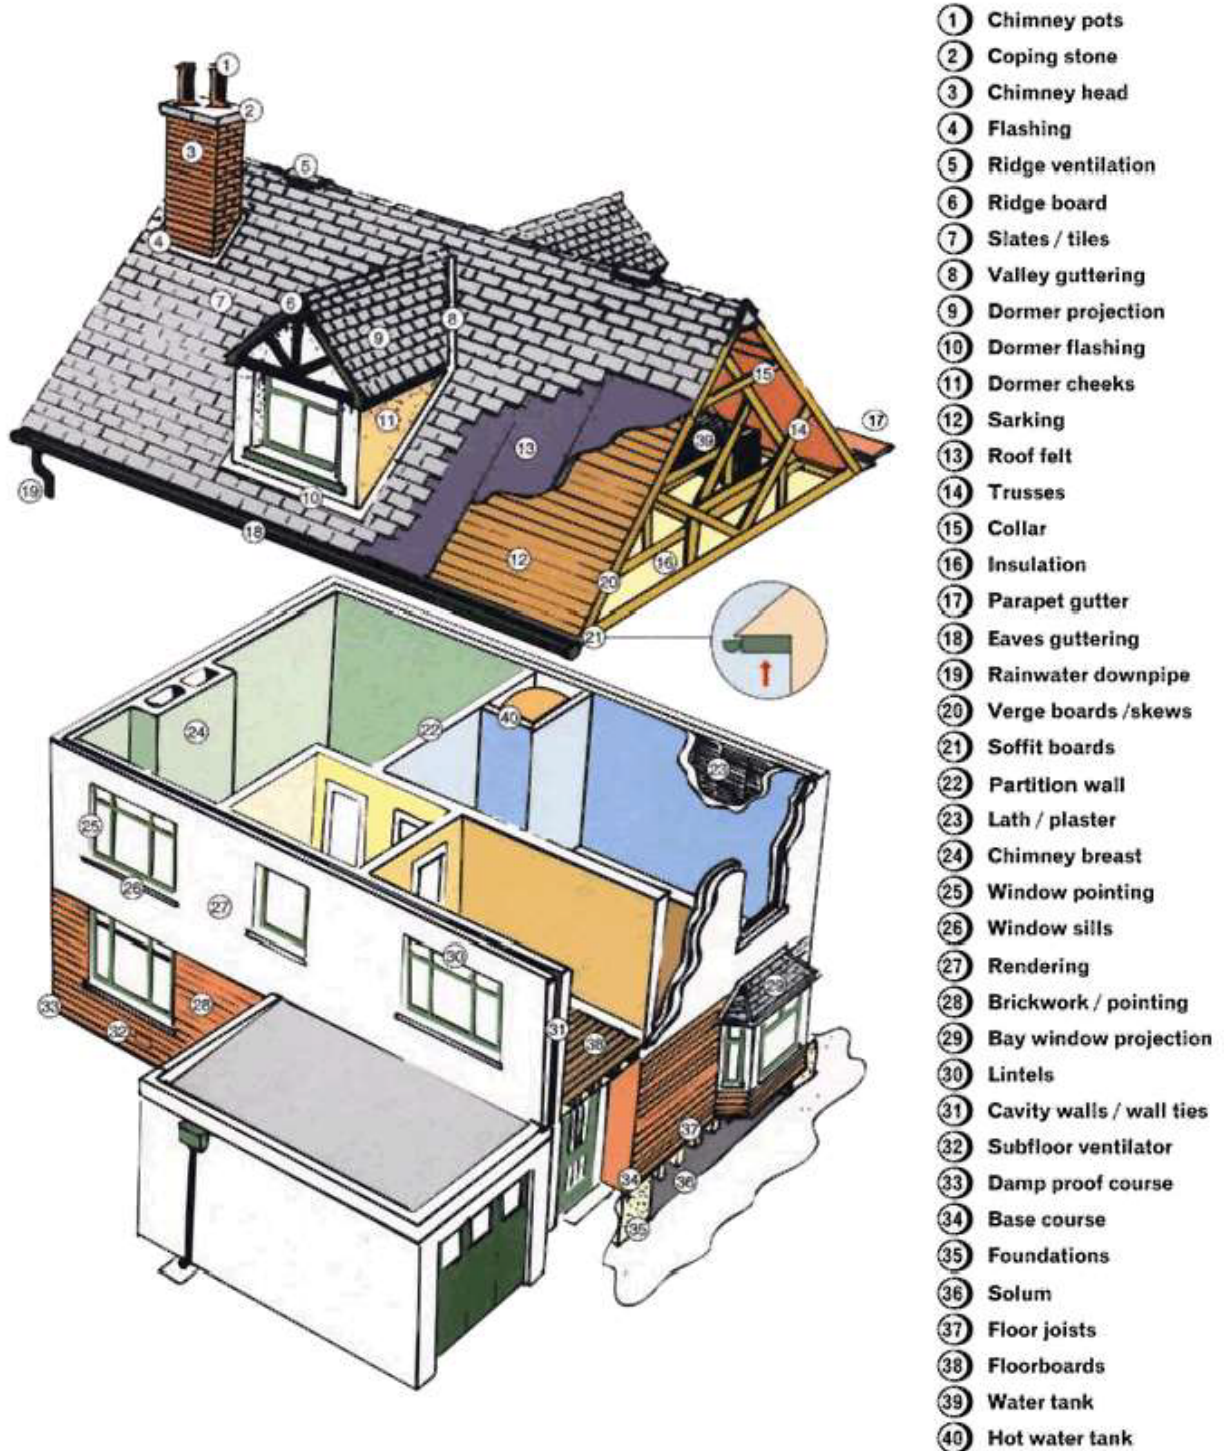
Sectional Diagram showing elements of a typical house

Reference may be made in this report to some or all of the above component parts of the property. This diagram may assist you in locating and understanding these items.

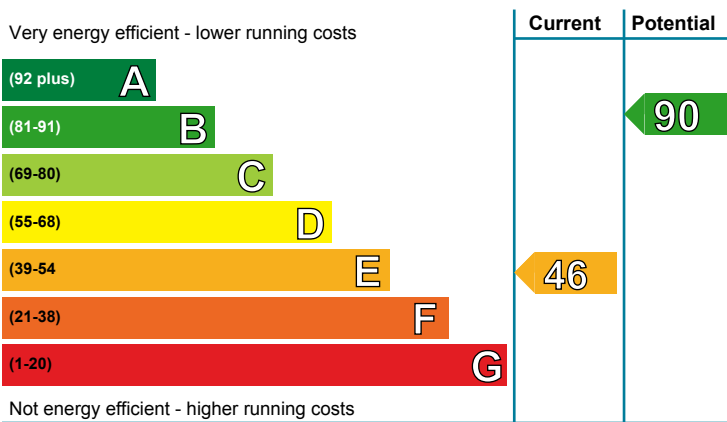
Energy Efficiency Rating

This graph shows the current efficiency of your home, taking into account both energy efficiency and fuel costs. The higher this rating, the lower your fuel bills are likely to be.

Your current rating is **band E (46)**. The average rating for EPCs in Scotland is **band D (61)**.

The potential rating shows the effect of undertaking all of the improvement measures listed within your recommendations report.

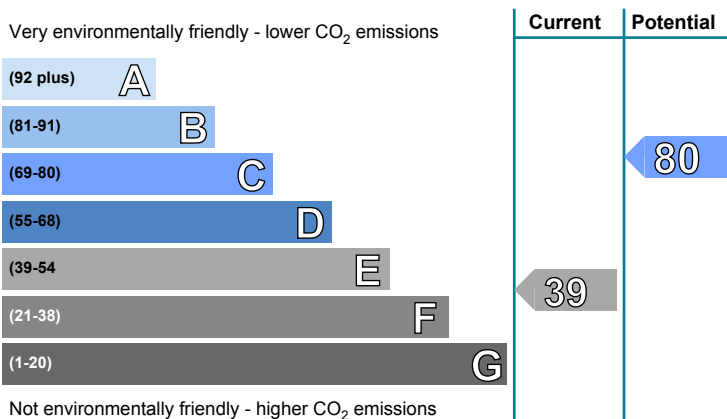
Environmental Impact (CO₂) Rating

This graph shows the effect of your home on the environment in terms of carbon dioxide (CO₂) emissions. The higher the rating, the less impact it has on the environment.

The potential rating shows the effect of undertaking all of the improvement measures listed within your recommendations report.
