YOUR ONESURVEY
HOME REPORT

Flat 0/2
2 Auldhouse Avenue
Glasgow
G43 1DN

SINGLE SURVEY

Single Survey

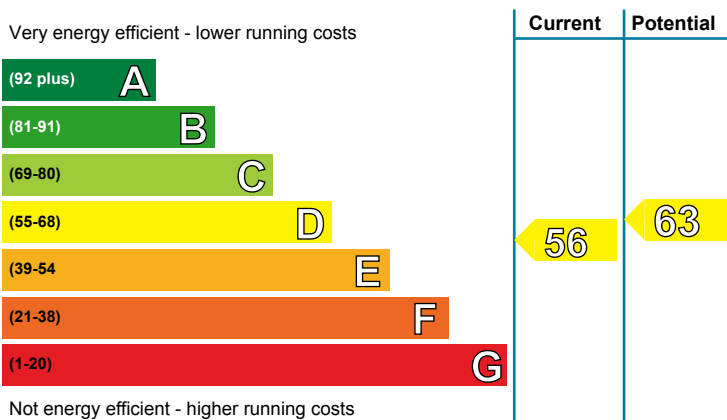
Energy Efficiency Rating

This graph shows the current efficiency of your home, taking into account both energy efficiency and fuel costs. The higher this rating, the lower your fuel bills are likely to be.

Your current rating is **band D (56)**. The average rating for EPCs in Scotland is **band D (61)**.

The potential rating shows the effect of undertaking all of the improvement measures listed within your recommendations report.

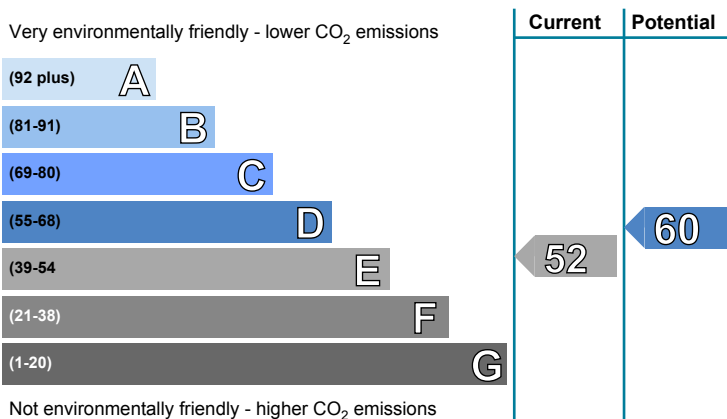
Environmental Impact (CO₂) Rating

This graph shows the effect of your home on the environment in terms of carbon dioxide (CO₂) emissions. The higher the rating, the less impact it has on the environment.
