Home Report

Single Survey

Property address	Fearnoch Station Road Langbank Port Glasgow PA14 6YA
Customer	Mrs Wilma Abernethy
Customer address	Fearnoch Station Road Langbank Port Glasgow PA14 6YA
Prepared by	Shepherd Chartered Surveyors
Date of inspection	19/01/2026

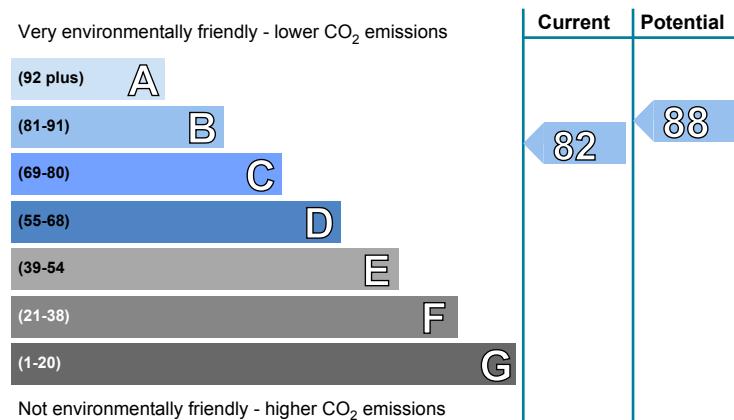
Environmental Impact (CO₂) Rating

This graph shows the effect of your home on the environment in terms of carbon dioxide (CO₂) emissions. The higher the rating, the less impact it has on the environment.
