9 Fernside,
Brisbane Street,
Largs,
Ayrshire,
KA30 8QG

Home Report

Single Survey

Property Address	9 Fernside, Brisbane Street, Largs, Ayrshire, KA30 8QG
Reference	1400714
Customer Name	Lindsay Johnstone
Date of Inspection	3rd April 2026
Surveyor's name, qualifications and office	Greg Fisher BSc (hons) MSc MRICS DM Hall LLP Chartered Surveyors Eldo House, Monkton Road, Prestwick, KA9 2PB Tel: 01292 286974 email: ayrshireresidential@dmhall.co.uk
Prepared By	DM Hall LLP

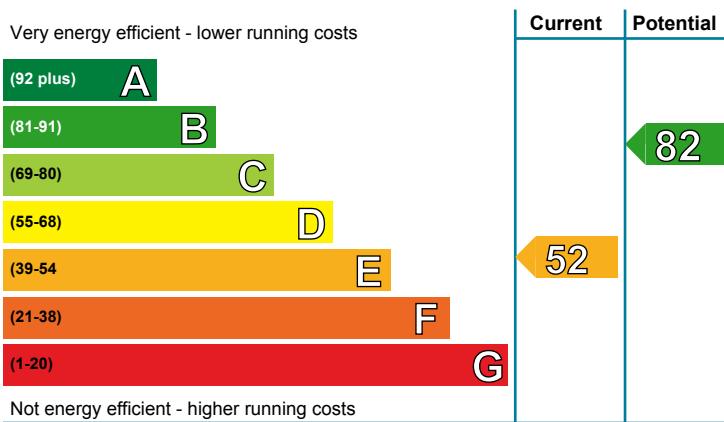
Energy Efficiency Rating

This graph shows the current efficiency of your home, taking into account both energy efficiency and fuel costs. The higher this rating, the lower your fuel bills are likely to be.

Your current rating is **band E (52)**. The average rating for EPCs in Scotland is **band D (61)**.

The potential rating shows the effect of undertaking all of the improvement measures listed within your recommendations report.

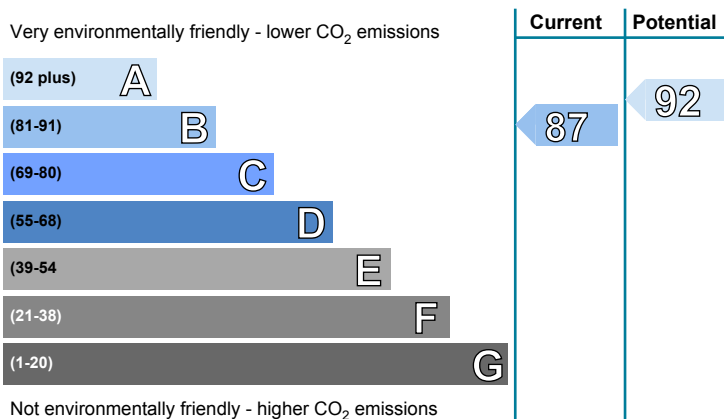
Environmental Impact (CO₂) Rating

This graph shows the effect of your home on the environment in terms of carbon dioxide (CO₂) emissions. The higher the rating, the less impact it has on the environment.
