YOUR ONESURVEY
HOME REPORT

69a Fergus Drive
North Kelvinside
Glasgow
G20 6AH

SINGLE SURVEY

Single Survey

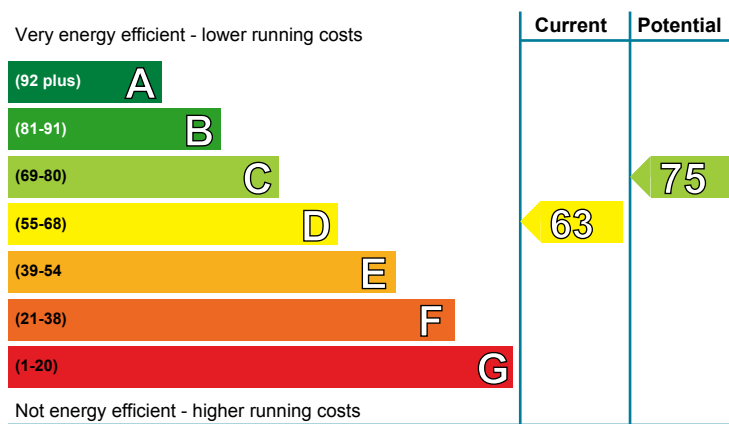
Energy Efficiency Rating

This graph shows the current efficiency of your home, taking into account both energy efficiency and fuel costs. The higher this rating, the lower your fuel bills are likely to be.

Your current rating is **band D (63)**. The average rating for EPCs in Scotland is **band D (61)**.

The potential rating shows the effect of undertaking all of the improvement measures listed within your recommendations report.

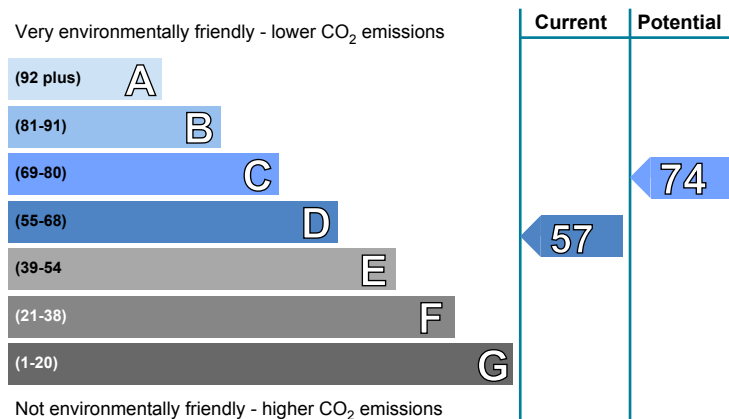
Environmental Impact (CO₂) Rating

This graph shows the effect of your home on the environment in terms of carbon dioxide (CO₂) emissions. The higher the rating, the less impact it has on the environment.
