# Home Report

# Scottish Single Survey

| Property address | Flat C<br>23 Malcolm Road<br>Peterculter<br>AB14 0XA |
| Prepared by | Shepherd Chartered Surveyors |

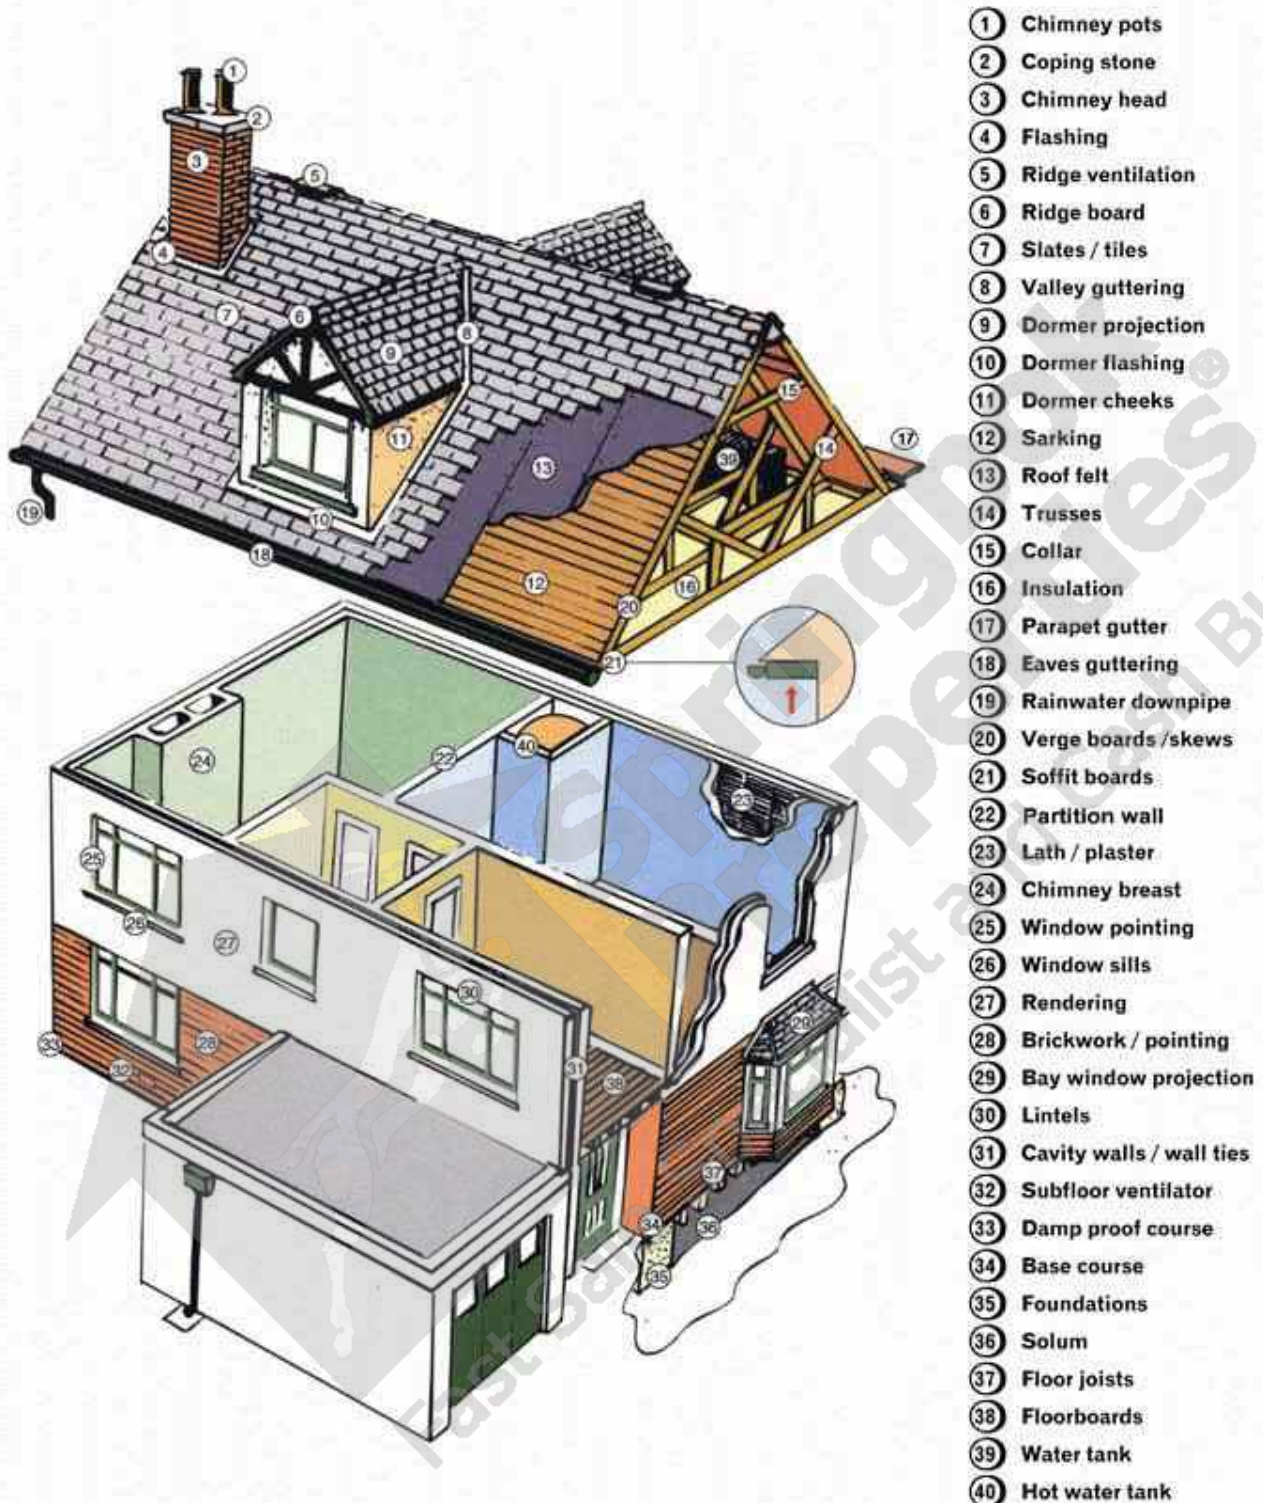
## Sectional Diagram showing elements of a typical house

Reference may be made in this report to some or all of the above component parts of the property. This diagram may assist you in locating and understanding these items.

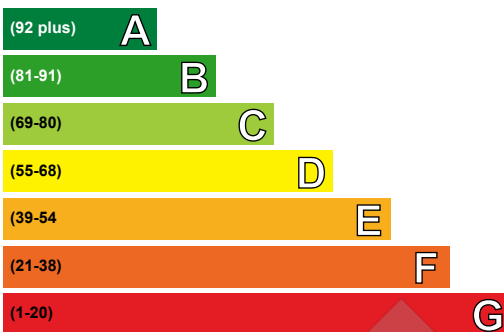
\* based upon the cost of energy for heating, hot water, lighting and ventilation, calculated using standard assumptions

Very energy efficient - lower running costs

Not energy efficient - higher running costs

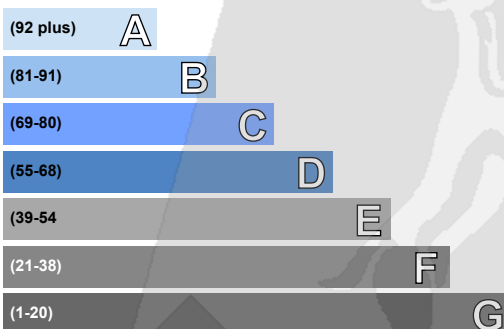
Very environmentally friendly - lower CO<sub>2</sub> emissions

Not environmentally friendly - higher CO<sub>2</sub> emissions
