# home report

**208B LIVINGSTONE TERRACE  
IRVINE  
KA12 9JT**

# Energy Performance Certificate (EPC)

208B LIVINGSTONE TERRACE, IRVINE, KA12 9JT

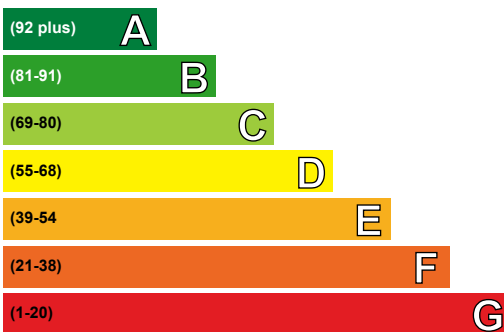
## Energy Efficiency Rating

This graph shows the current efficiency of your home, taking into account both energy efficiency and fuel costs. The higher this rating, the lower your fuel bills are likely to be.

Your current rating is **band D (66)**. The average rating for EPCs in Scotland is **band D (61)**.

The potential rating shows the effect of undertaking all of the improvement measures listed within your recommendations report.

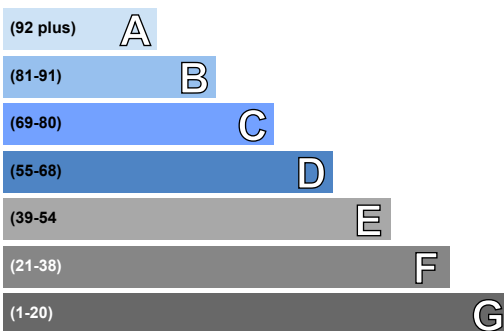
Very environmentally friendly - lower CO<sub>2</sub> emissions

Not environmentally friendly - higher CO<sub>2</sub> emissions

The potential rating shows the effect of undertaking all of the improvement measures listed within your recommendations report.

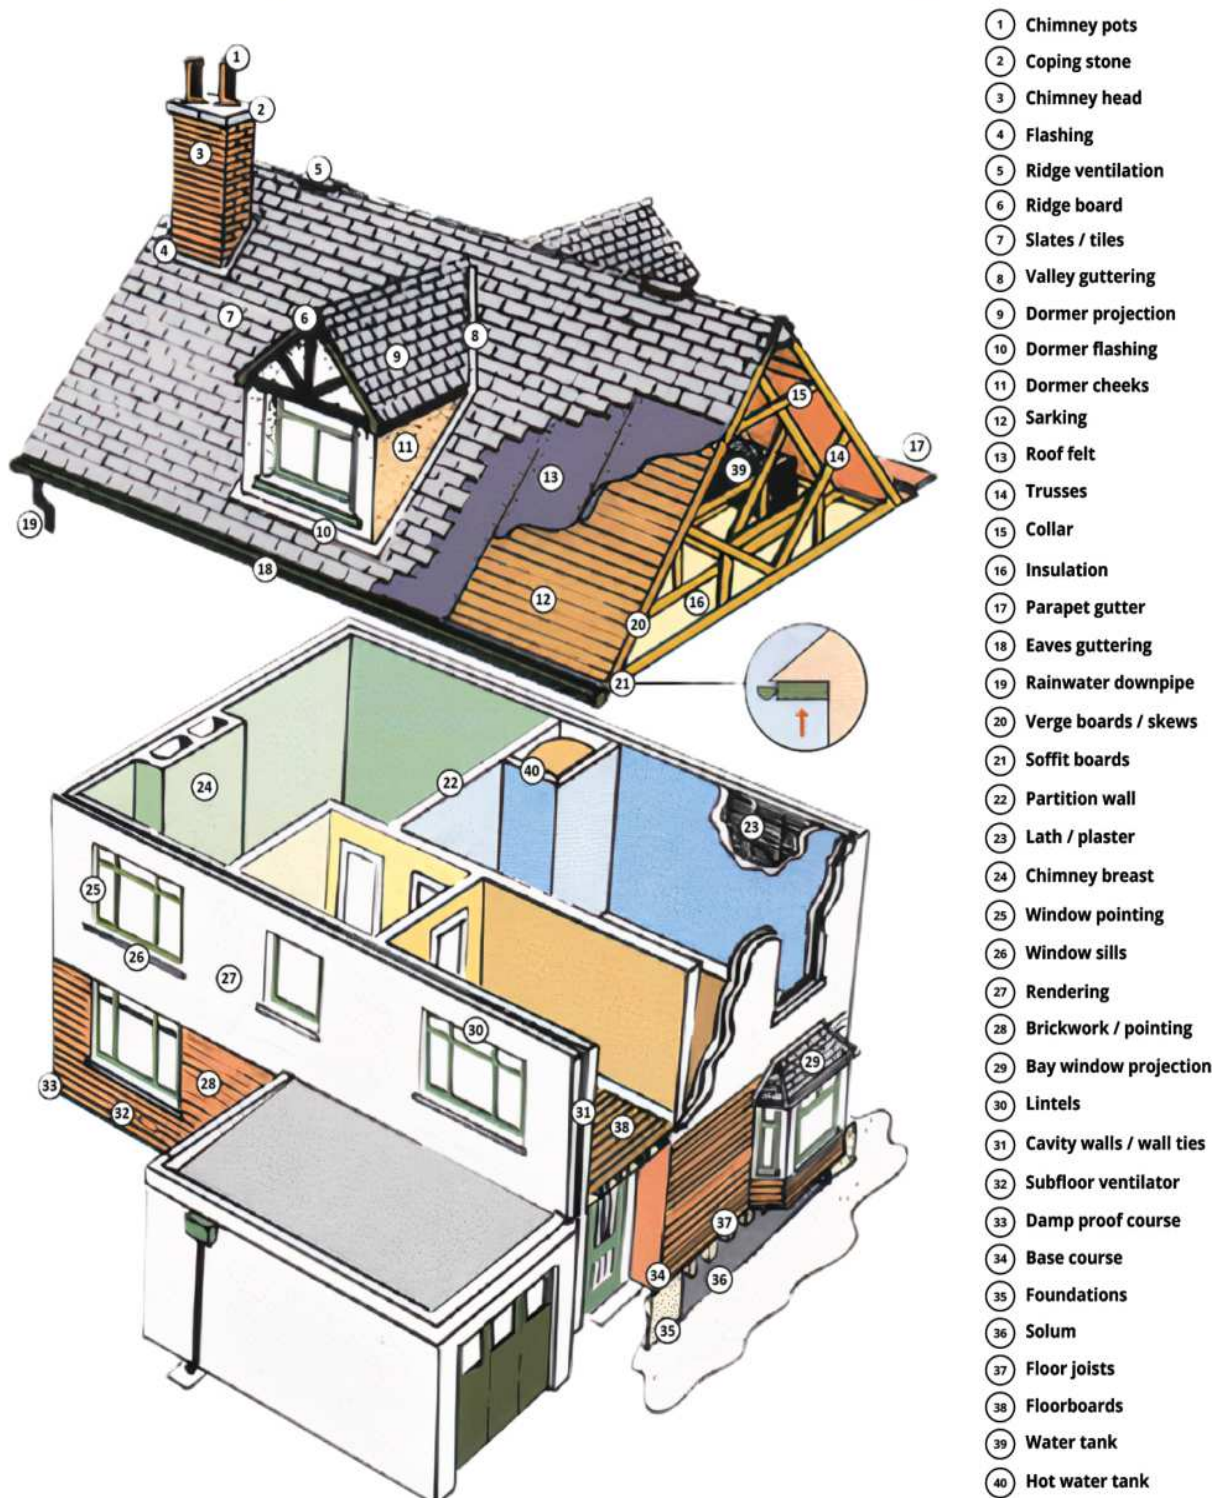
## Sectional Diagram showing elements of a typical house

Reference may be made in this report to some or all of the above component parts of the property. This diagram may assist you in locating and understanding these items.
