1/R 7,
High Street,
Monifieth,
Dundee,
DD5 4DA

Home Report

Single Survey

Property Address	1/R 7, High Street, Monifieth, Dundee, DD5 4DA
Reference	DD202602-52191
Customer Name	Jack McNeill
Date of Inspection	2nd March 2026
Surveyor's name, qualifications and office	Jack Chinery AssocRICS DM Hall LLP Chartered Surveyors Shed 26, Unit 34, City Quay Camperdown Street Dundee DD1 3JA Tel: 01382 873100 email: dundeeresidential@dmhall.co.uk
Prepared By	DM Hall LLP

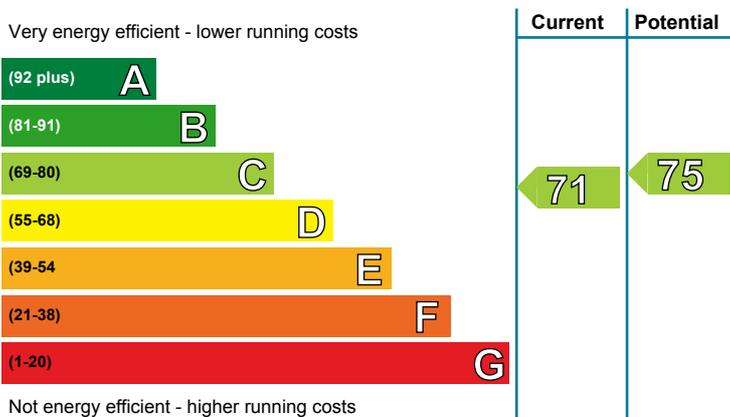
Energy Efficiency Rating

This graph shows the current efficiency of your home, taking into account both energy efficiency and fuel costs. The higher this rating, the lower your fuel bills are likely to be.

Your current rating is **band C (71)**. The average rating for EPCs in Scotland is **band D (61)**.

The potential rating shows the effect of undertaking all of the improvement measures listed within your recommendations report.

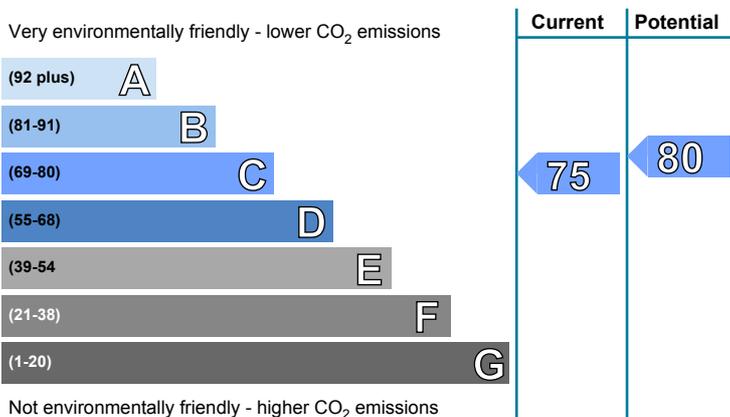
Environmental Impact (CO₂) Rating

This graph shows the effect of your home on the environment in terms of carbon dioxide (CO₂) emissions. The higher the rating, the less impact it has on the environment.
