YOUR ONESURVEY
HOME REPORT

10 Belhaven Terrace
Glasgow
G12 0TG

SINGLE SURVEY

Single Survey

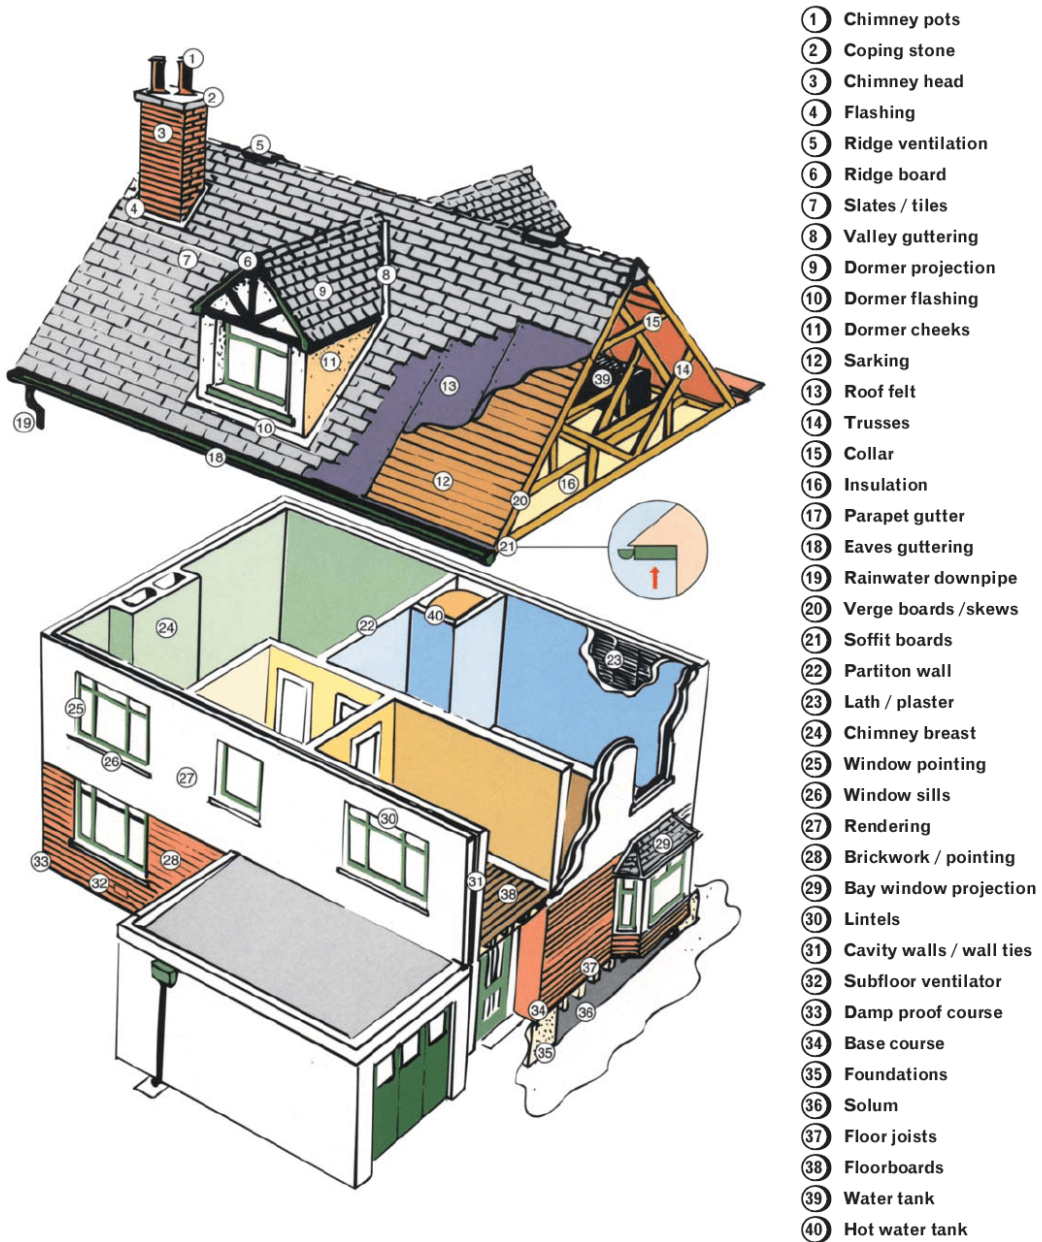
Sectional Diagram showing elements of a typical house

Reference may be made in this report to some or all of the above component parts of the property. This diagram may assist you in locating and understanding these items.
