Home Report

Single Survey

Property address	Tarramarr Ferry Road South Alloa Stirling FK7 7LF
Customer	Mary Anne McAdam
Customer address	Tarramarr Ferry Road South Alloa Stirling FK7 7LF
Prepared by	Shepherd Chartered Surveyors
Date of inspection	12/02/2026

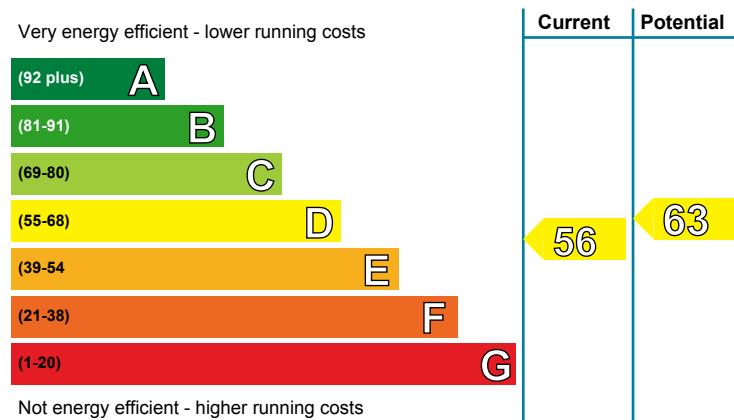
Energy Efficiency Rating

This graph shows the current efficiency of your home, taking into account both energy efficiency and fuel costs. The higher this rating, the lower your fuel bills are likely to be.

Your current rating is **band D (56)**. The average rating for EPCs in Scotland is **band D (61)**.

The potential rating shows the effect of undertaking all of the improvement measures listed within your recommendations report.

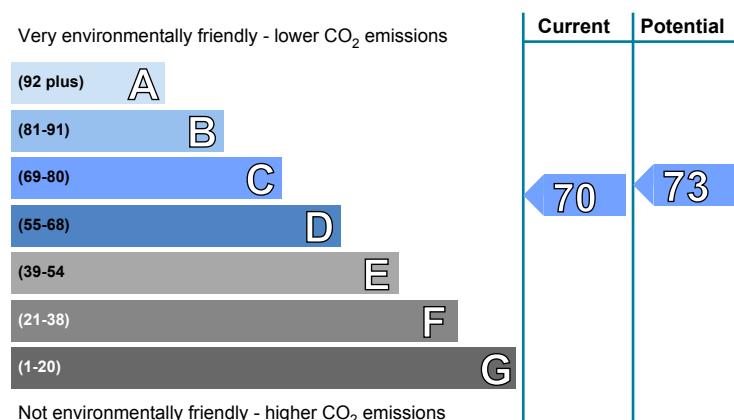
Environmental Impact (CO₂) Rating

This graph shows the effect of your home on the environment in terms of carbon dioxide (CO₂) emissions. The higher the rating, the less impact it has on the environment.
