Flat 50,
Braehead,
Methven Walk,
Dundee,
DD2 3FJ

Home Report

Single Survey

Property Address	Flat 50, Braehead, Methven Walk, Dundee, DD2 3FJ
Reference	DD202604-56733
Customer Name	Ian Shearer
Date of Inspection	15th April 2026
Surveyor's name, qualifications and office	Jack Chinery AssocRICS DM Hall LLP Chartered Surveyors Shed 26, Unit 34, City Quay Camperdown Street Dundee DD1 3JA Tel: 01382 873100 email: dundeeresidential@dmhall.co.uk
Prepared By	DM Hall LLP

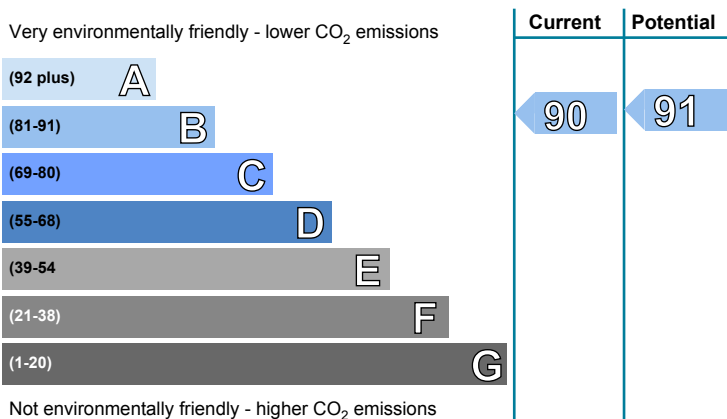
Environmental Impact (CO₂) Rating

This graph shows the effect of your home on the environment in terms of carbon dioxide (CO₂) emissions. The higher the rating, the less impact it has on the environment.
