# home report

**29 COLUMBA CRESCENT  
FORGEWOOD  
MOTHERWELL  
ML1 3XU**

# Energy Performance Certificate (EPC)

# Single Survey

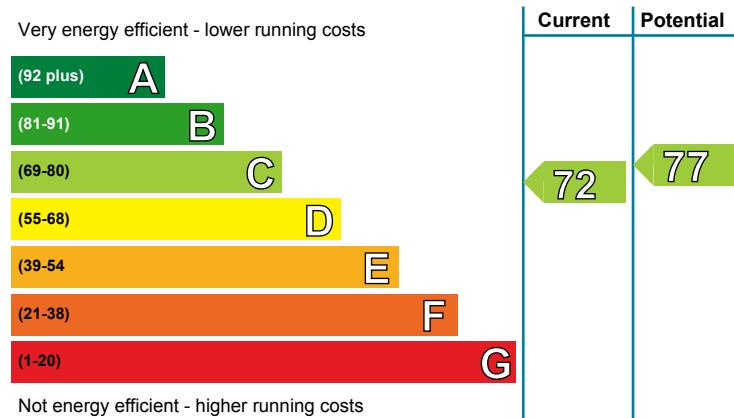
## Energy Efficiency Rating

This graph shows the current efficiency of your home, taking into account both energy efficiency and fuel costs. The higher this rating, the lower your fuel bills are likely to be.

Your current rating is **band C (72)**. The average rating for EPCs in Scotland is **band D (61)**.

The potential rating shows the effect of undertaking all of the improvement measures listed within your recommendations report.

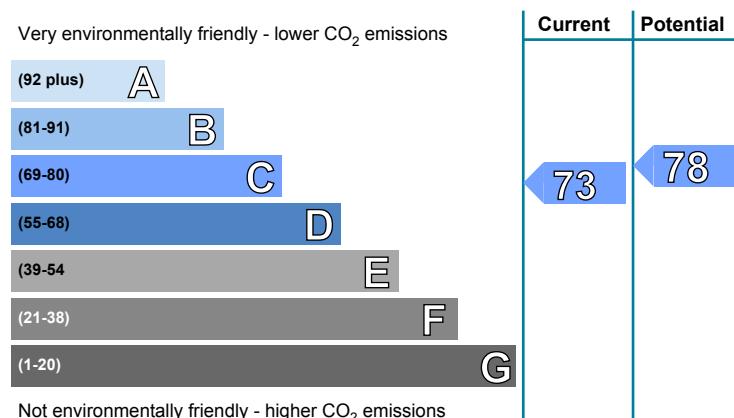
## Environmental Impact (CO<sub>2</sub>) Rating

This graph shows the effect of your home on the environment in terms of carbon dioxide (CO<sub>2</sub>) emissions. The higher the rating, the less impact it has on the environment.

Your current rating is **band C (73)**

The potential rating shows the effect of undertaking all of the improvement measures listed within your recommendations report.

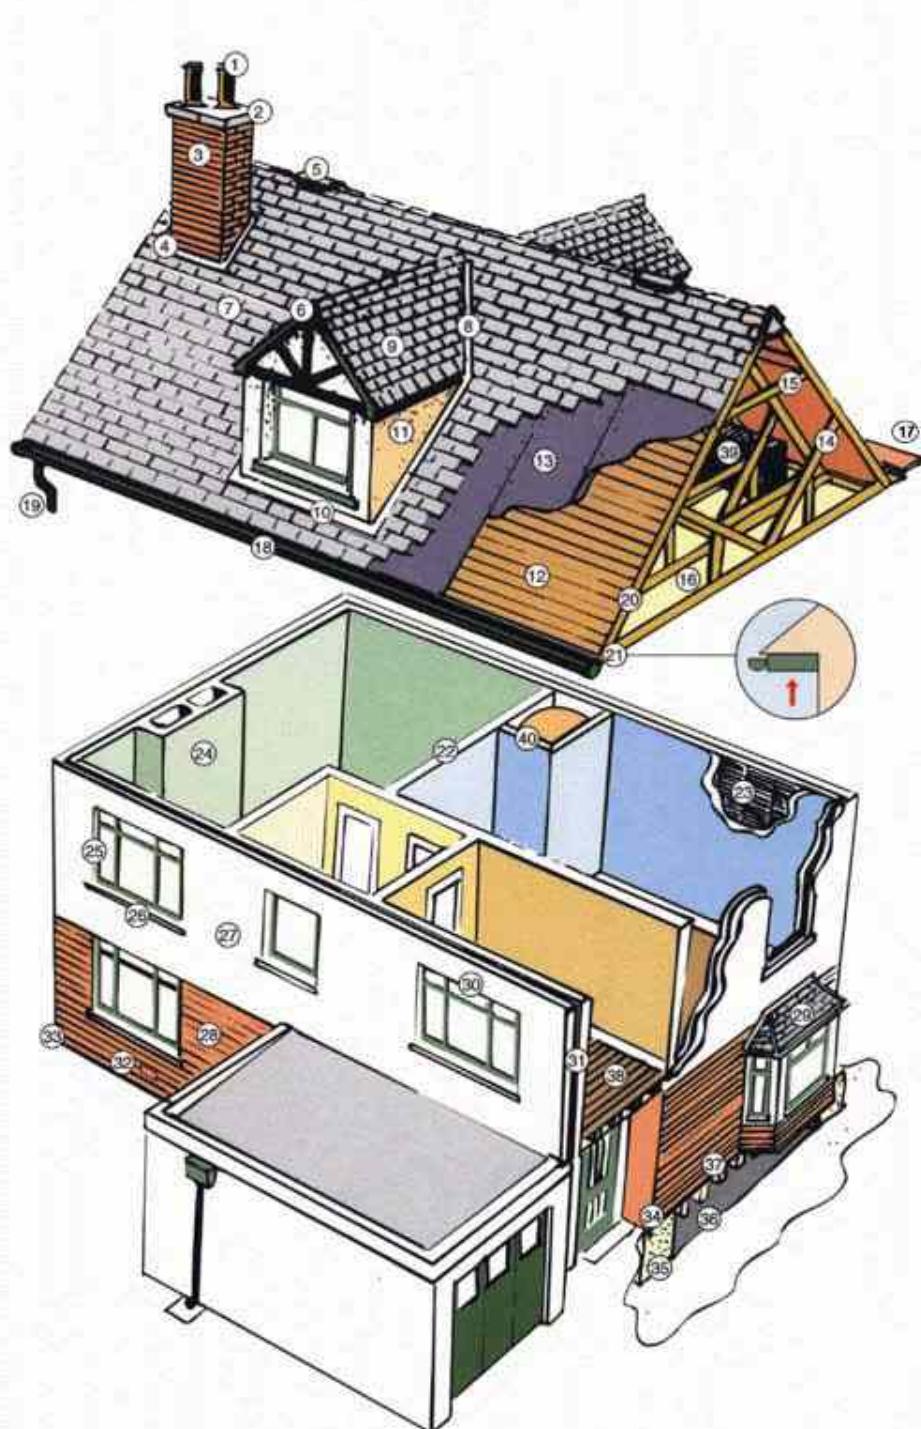
## Sectional Diagram showing elements of a typical house

- 1 Chimney pots
- 2 Coping stone
- 3 Chimney head
- 4 Flashing
- 5 Ridge ventilation
- 6 Ridge board
- 7 Slates / tiles
- 8 Valley guttering
- 9 Dormer projection
- 10 Dormer flashing
- 11 Dormer cheeks
- 12 Sarking
- 13 Roof felt
- 14 Trusses
- 15 Collar
- 16 Insulation
- 17 Parapet gutter
- 18 Eaves guttering
- 19 Rainwater downpipe
- 20 Verge boards /skews
- 21 Soffit boards
- 22 Partition wall
- 23 Lath / plaster
- 24 Chimney breast
- 25 Window pointing
- 26 Window sills
- 27 Rendering
- 28 Brickwork / pointing
- 29 Bay window projection
- 30 Lintels
- 31 Cavity walls / wall ties
- 32 Subfloor ventilator
- 33 Damp proof course
- 34 Base course
- 35 Foundations
- 36 Solum
- 37 Floor joists
- 38 Floorboards
- 39 Water tank
- 40 Hot water tank

Reference may be made in this report to some or all of the above component parts of the property. This diagram may assist you in locating and understanding these items.
