# Home Report

# Scottish Single Survey

<b>Property address</b>	287 Sandpiper Drive East Kilbride Glasgow G75 8UN
<b>Customer</b>	Michelle Nixon
<b>Customer address</b>	287 Sandpiper Drive East Kilbride Glasgow G75 8UN
<b>Prepared by</b>	Shepherd Chartered Surveyors
<b>Date of inspection</b>	11/02/2026

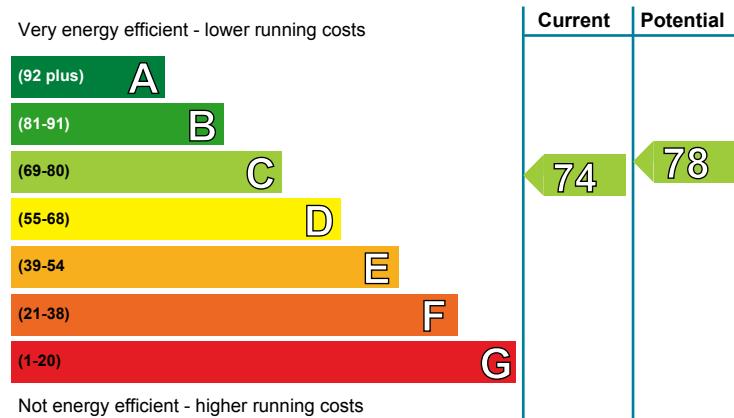
## Energy Efficiency Rating

This graph shows the current efficiency of your home, taking into account both energy efficiency and fuel costs. The higher this rating, the lower your fuel bills are likely to be.

Your current rating is **band C (74)**. The average rating for EPCs in Scotland is **band D (61)**.

The potential rating shows the effect of undertaking all of the improvement measures listed within your recommendations report.
