Home Report

Scottish Single Survey

Property address	140 Park Terrace East Kilbride Glasgow G74 1BW
-------------------------	---

Prepared by	Shepherd Chartered Surveyors
--------------------	------------------------------

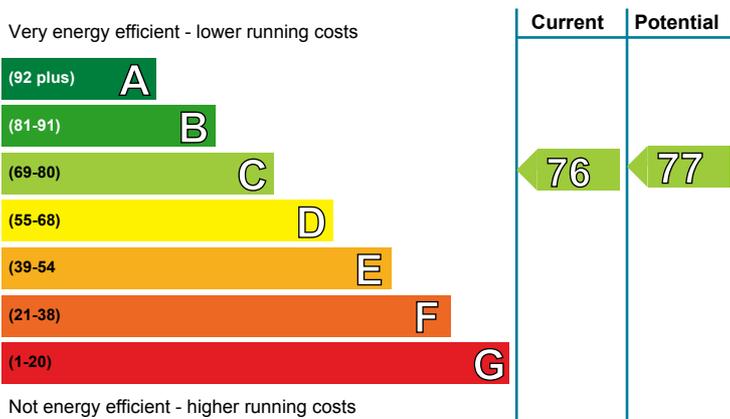
Energy Efficiency Rating

This graph shows the current efficiency of your home, taking into account both energy efficiency and fuel costs. The higher this rating, the lower your fuel bills are likely to be.

Your current rating is **band C (76)**. The average rating for EPCs in Scotland is **band D (61)**.

The potential rating shows the effect of undertaking all of the improvement measures listed within your recommendations report.

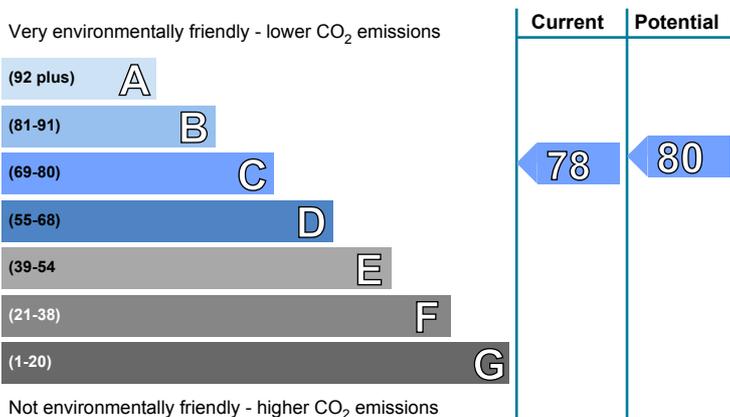
Environmental Impact (CO₂) Rating

This graph shows the effect of your home on the environment in terms of carbon dioxide (CO₂) emissions. The higher the rating, the less impact it has on the environment.
