# Home Report

Fairlight 6 Drumbeg Road  
Turnberry KA26 9LW

# Single Survey

<b>Property Address</b>	Fairlight 6 Drumbeg Road Turnberry KA26 9LW
<b>Customer</b>	Mr & Mrs Hogarth
<b>Prepared by</b>	Graham + Sibbald Property Consultants Limited
<b>Date of Inspection</b>	27/03/2026

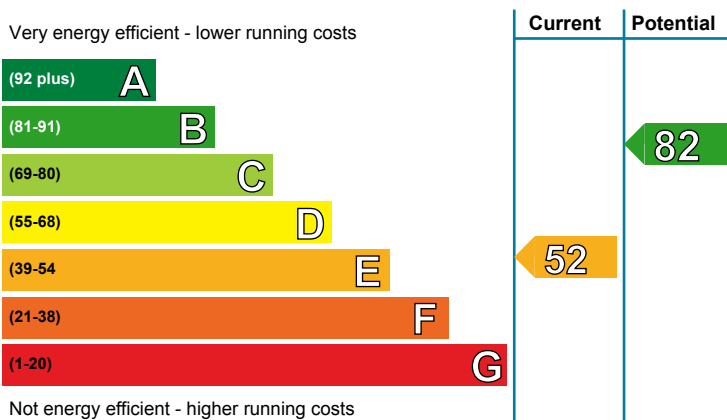
## Energy Efficiency Rating

This graph shows the current efficiency of your home, taking into account both energy efficiency and fuel costs. The higher this rating, the lower your fuel bills are likely to be.

Your current rating is **band E (52)**. The average rating for EPCs in Scotland is **band D (61)**.

The potential rating shows the effect of undertaking all of the improvement measures listed within your recommendations report.
