# Home Report

10 Midton Road  
Ayr KA7 2SF

# Single Survey

<b>Property Address</b>	10 Midton Road Ayr KA7 2SF
<b>Customer</b>	Oliver & Liana Rowe
<b>Prepared by</b>	Graham + Sibbald Property Consultants Limited
<b>Date of Inspection</b>	29/06/2026

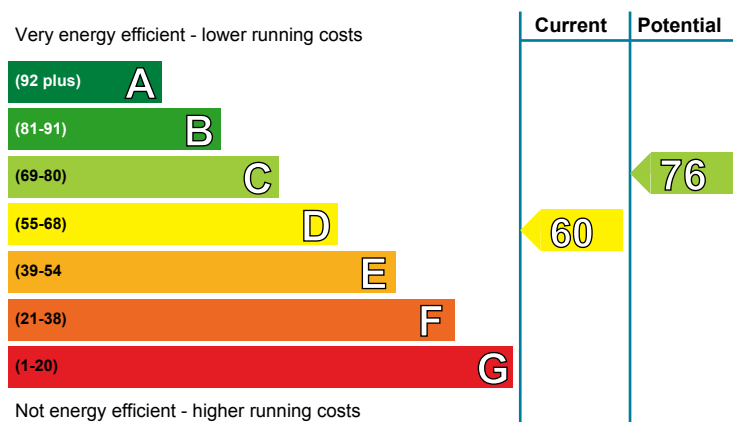
## Energy Efficiency Rating

This graph shows the current efficiency of your home, taking into account both energy efficiency and fuel costs. The higher this rating, the lower your fuel bills are likely to be.

Your current rating is **band D (60)**. The average rating for EPCs in Scotland is **band D (61)**.

The potential rating shows the effect of undertaking all of the improvement measures listed within your recommendations report.
