# Home Report

# Single Survey

| Property address | 73 Balloan Road<br>Inverness<br>IV2 4JG |
| Prepared by | Shepherd Chartered Surveyors |

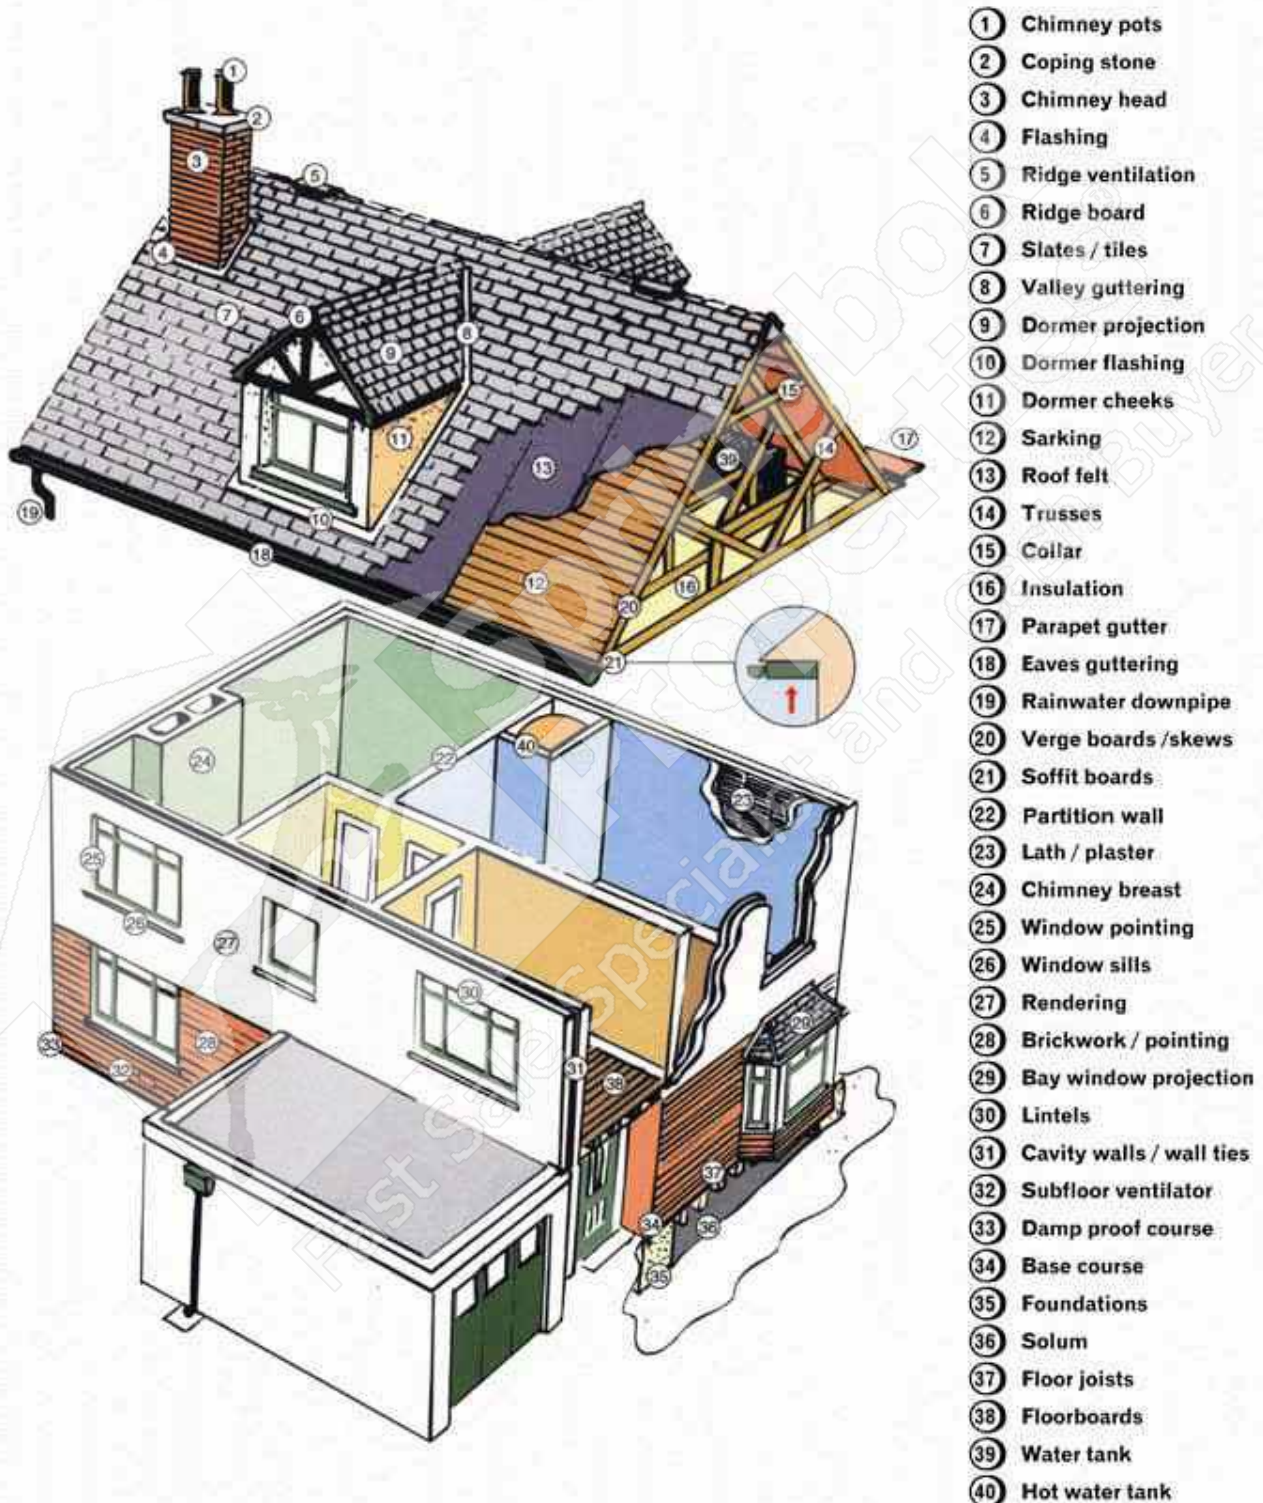
## Sectional Diagram showing elements of a typical house

Reference may be made in this report to some or all of the above component parts of the property. This diagram may assist you in locating and understanding these items.
