# Home Report

## Scottish Single Survey

# Single Survey

| Property address | 161 Lochdochart Road<br>Glasgow<br>G34 0GN |

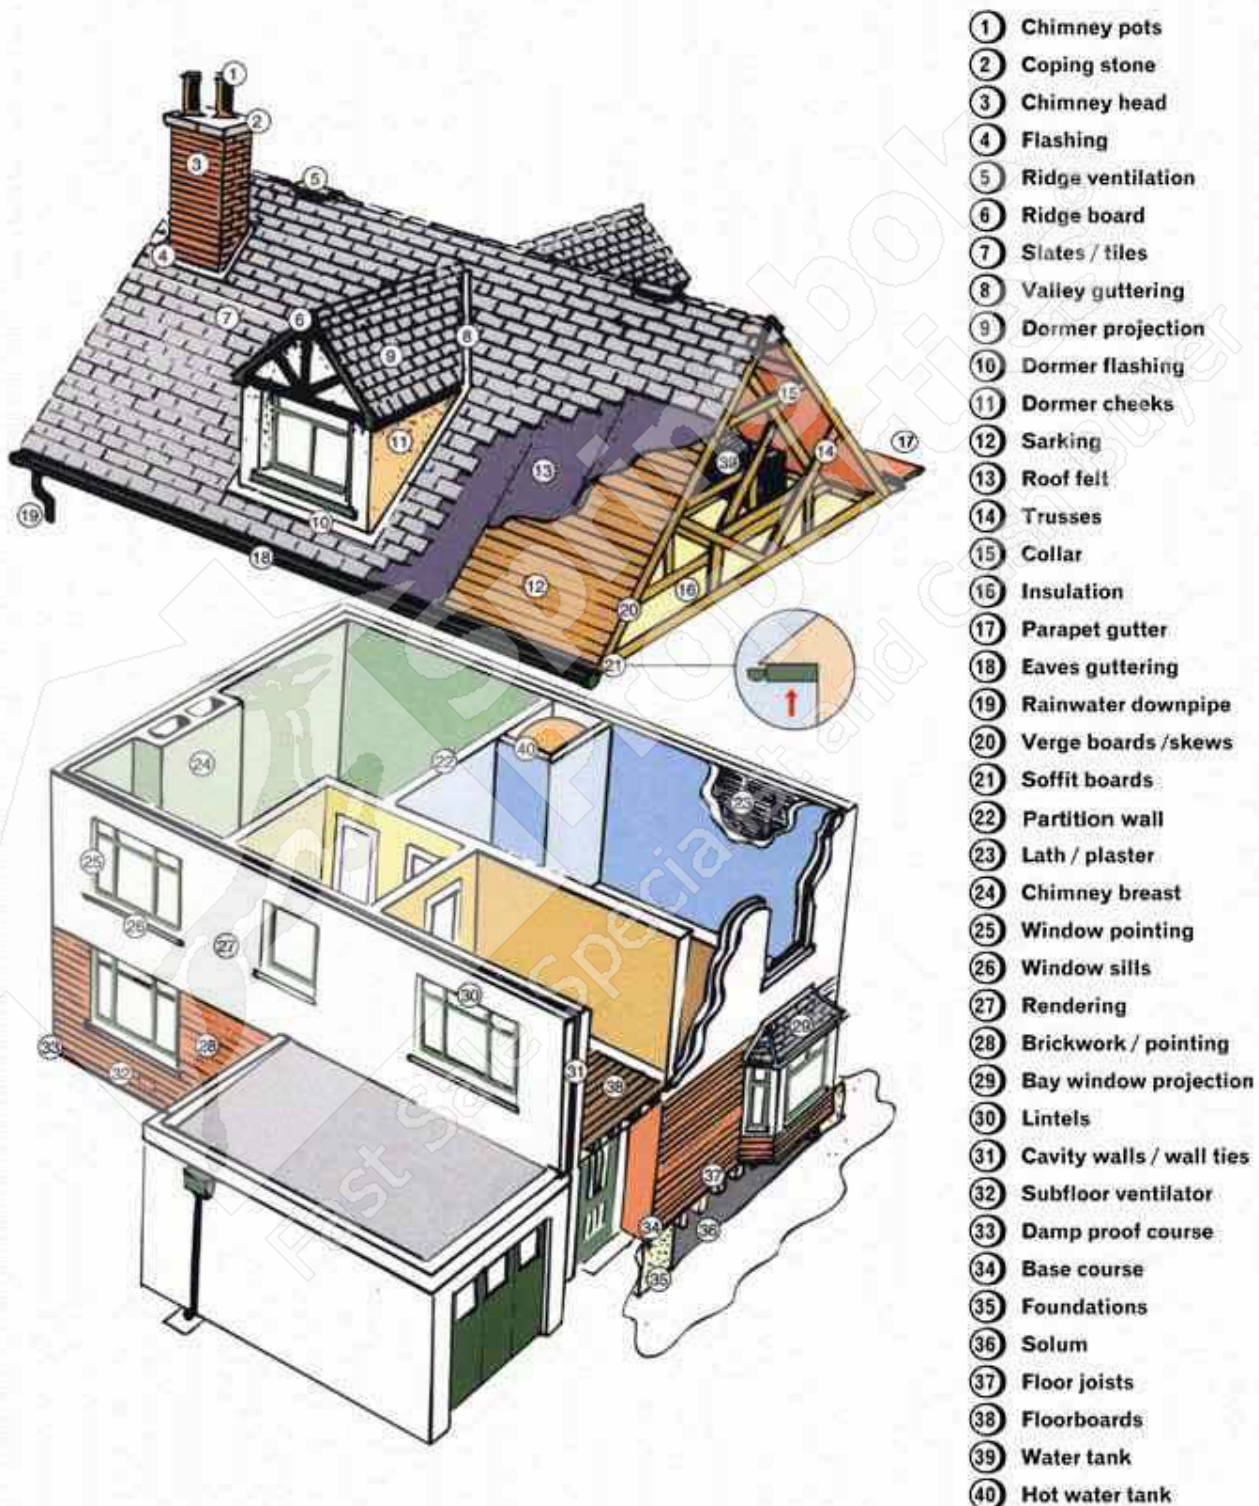
## Sectional Diagram showing elements of a typical house

Reference may be made in this report to some or all of the above component parts of the property. This diagram may assist you in locating and understanding these items.
