# Home Report

# Scottish Single Survey

| Property address | 2 Woodcroft Road<br>Bridge Of Don<br>Aberdeen<br>AB22 8DU |
| Prepared by | Shepherd Chartered Surveyors |

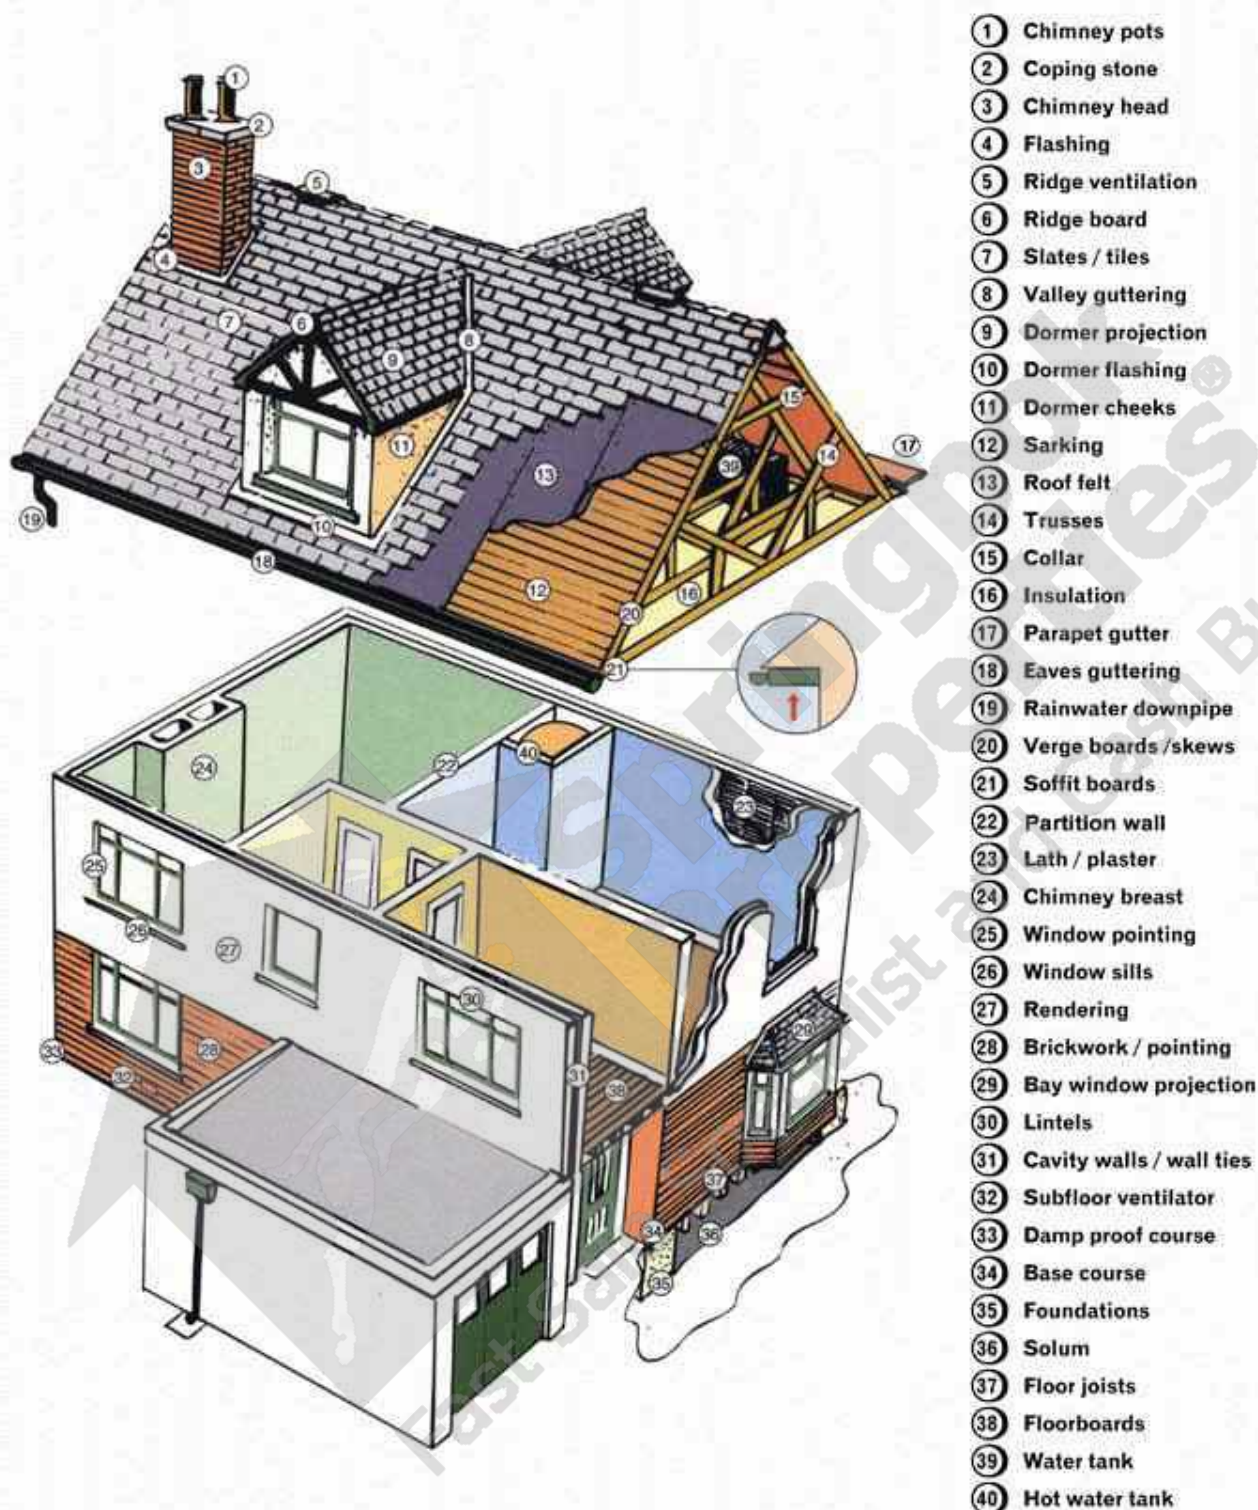
## Sectional Diagram showing elements of a typical house

Reference may be made in this report to some or all of the above component parts of the property. This diagram may assist you in locating and understanding these items.

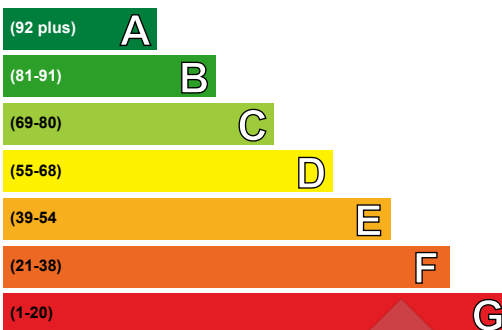
\* based upon the cost of energy for heating, hot water, lighting and ventilation, calculated using standard assumptions

Very energy efficient - lower running costs

Not energy efficient - higher running costs

The potential rating shows the effect of undertaking all of the improvement measures listed within your recommendations report.

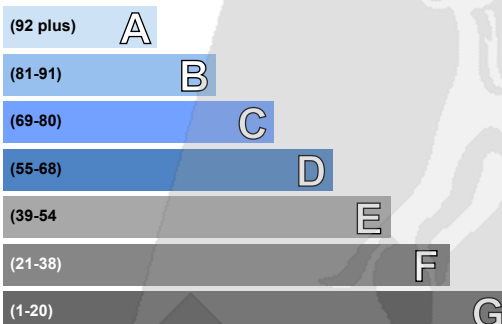
Very environmentally friendly - lower CO<sub>2</sub> emissions

Not environmentally friendly - higher CO<sub>2</sub> emissions
