YOUR ONESURVEY  
**HOME REPORT**

97 Crossmyloof Gardens  
Glasgow  
G41 4AY

# SINGLE SURVEY

A report on the condition of the property, with categories being rated from 1 to 3.

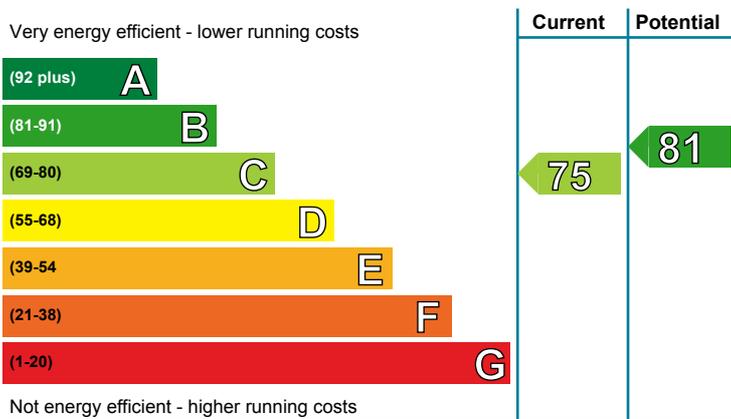
## Energy Efficiency Rating

This graph shows the current efficiency of your home, taking into account both energy efficiency and fuel costs. The higher this rating, the lower your fuel bills are likely to be.

Your current rating is **band C (75)**. The average rating for EPCs in Scotland is **band D (61)**.

The potential rating shows the effect of undertaking all of the improvement measures listed within your recommendations report.
