Home Report

18 Bowmore Court,
Lawthorn,
IRVINE,
KA11 2EA

Single Survey

Property Address	18 Bowmore Court, Lawthorn, IRVINE, KA11 2EA
Reference	1624679
Customer Name	Steven Walker
Date of Inspection	15th June 2026
Surveyor's name, qualifications and office	Kevin Masson BSc (Hons) MRICS DM Hall LLP Chartered Surveyors Eldo House, Monkton Road, Prestwick, KA9 2PB Tel: 01292 286974 email: ayrshireresidential@dmhall.co.uk
Prepared By	DM Hall LLP

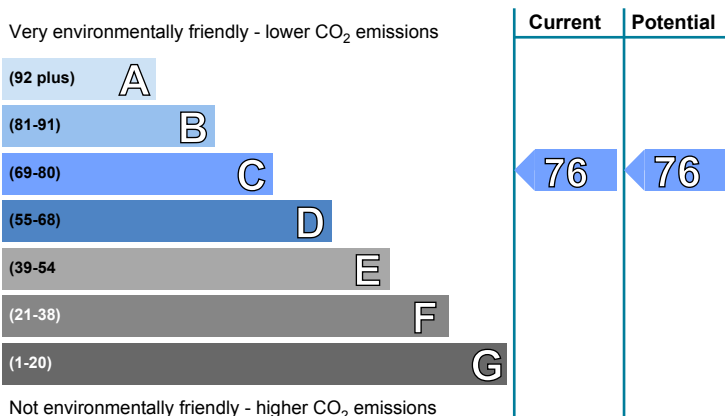
Environmental Impact (CO₂) Rating

This graph shows the effect of your home on the environment in terms of carbon dioxide (CO₂) emissions. The higher the rating, the less impact it has on the environment.
