12 Courthill Drive,  
GLENROTHES,  
KY7 4TW

# Home Report

# Single Survey

## Survey Report on:

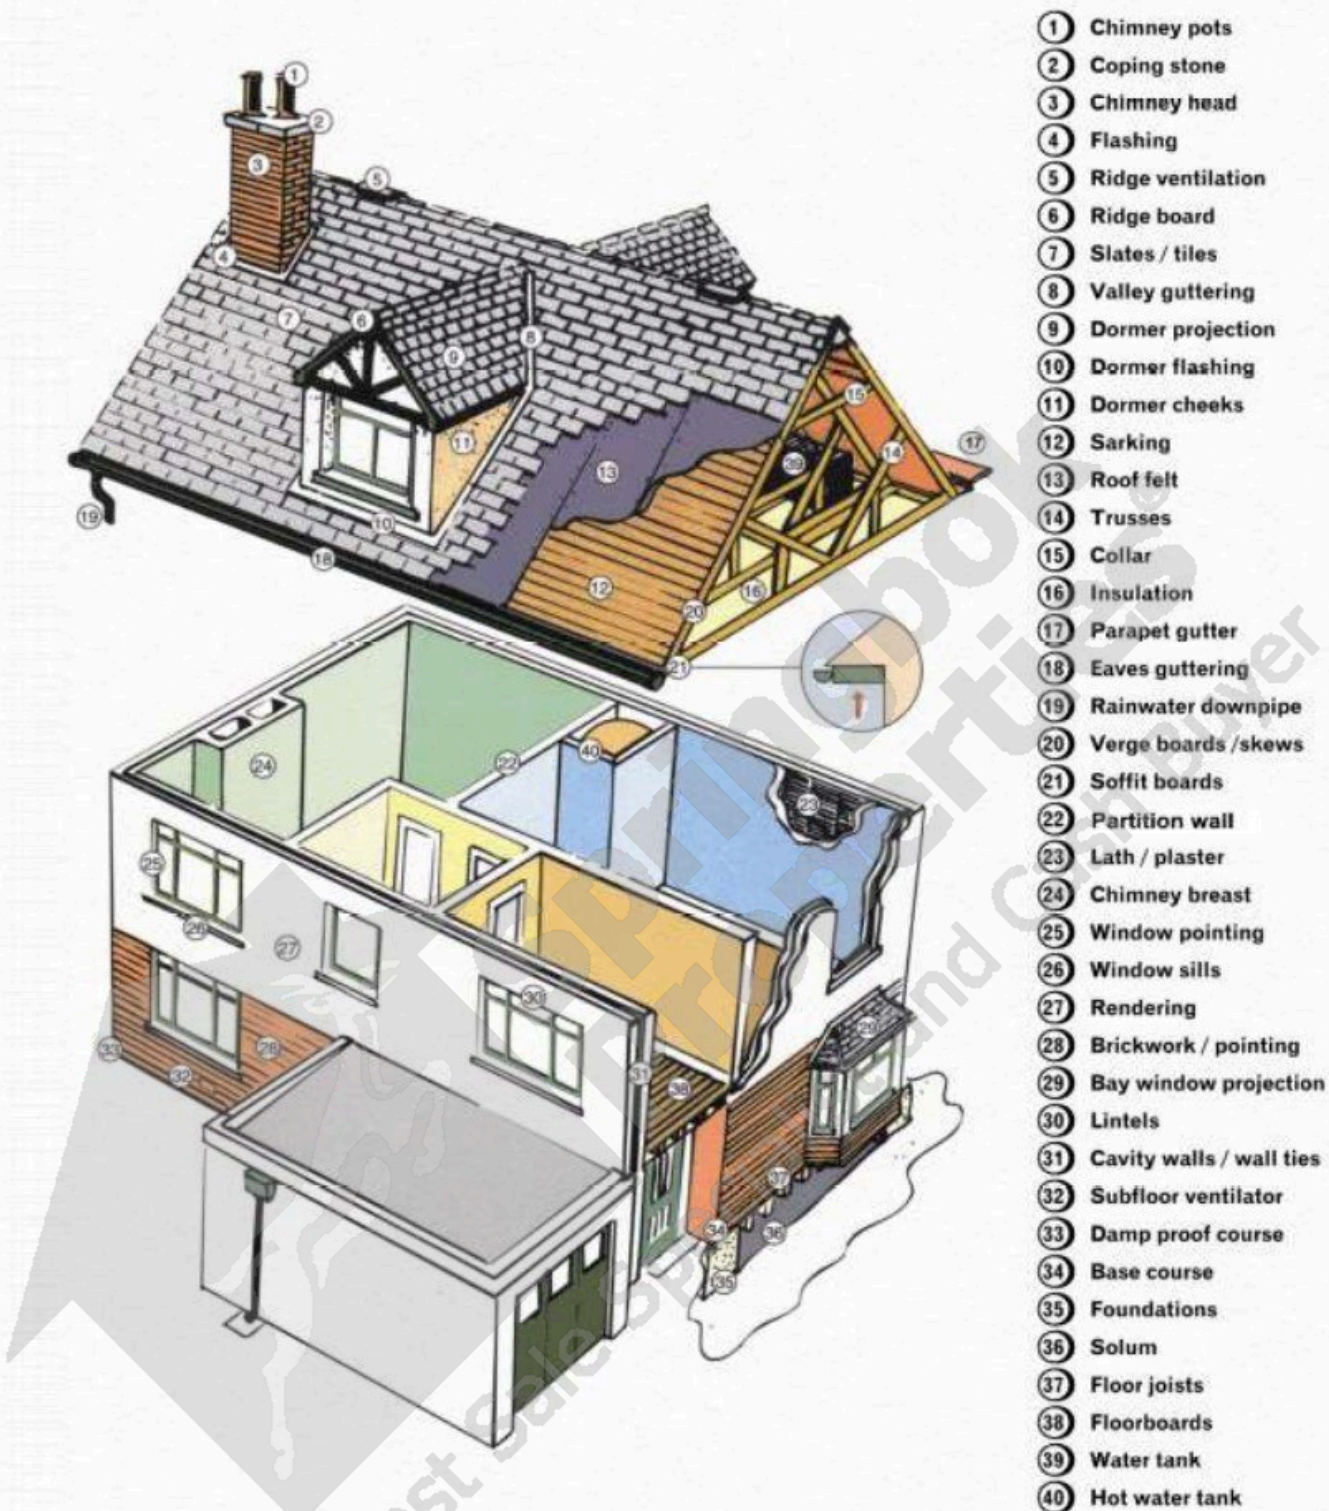
## Sectional Diagram showing elements of a typical house

Reference may be made in this report to some or all of the above component parts of the property. This diagram may assist you in locating and understanding these items.
