8 Kilmun Court,
Kilmun,
Dunoon,
Argyll,
PA23 8SF

Home Report

Single Survey

Survey Report on:

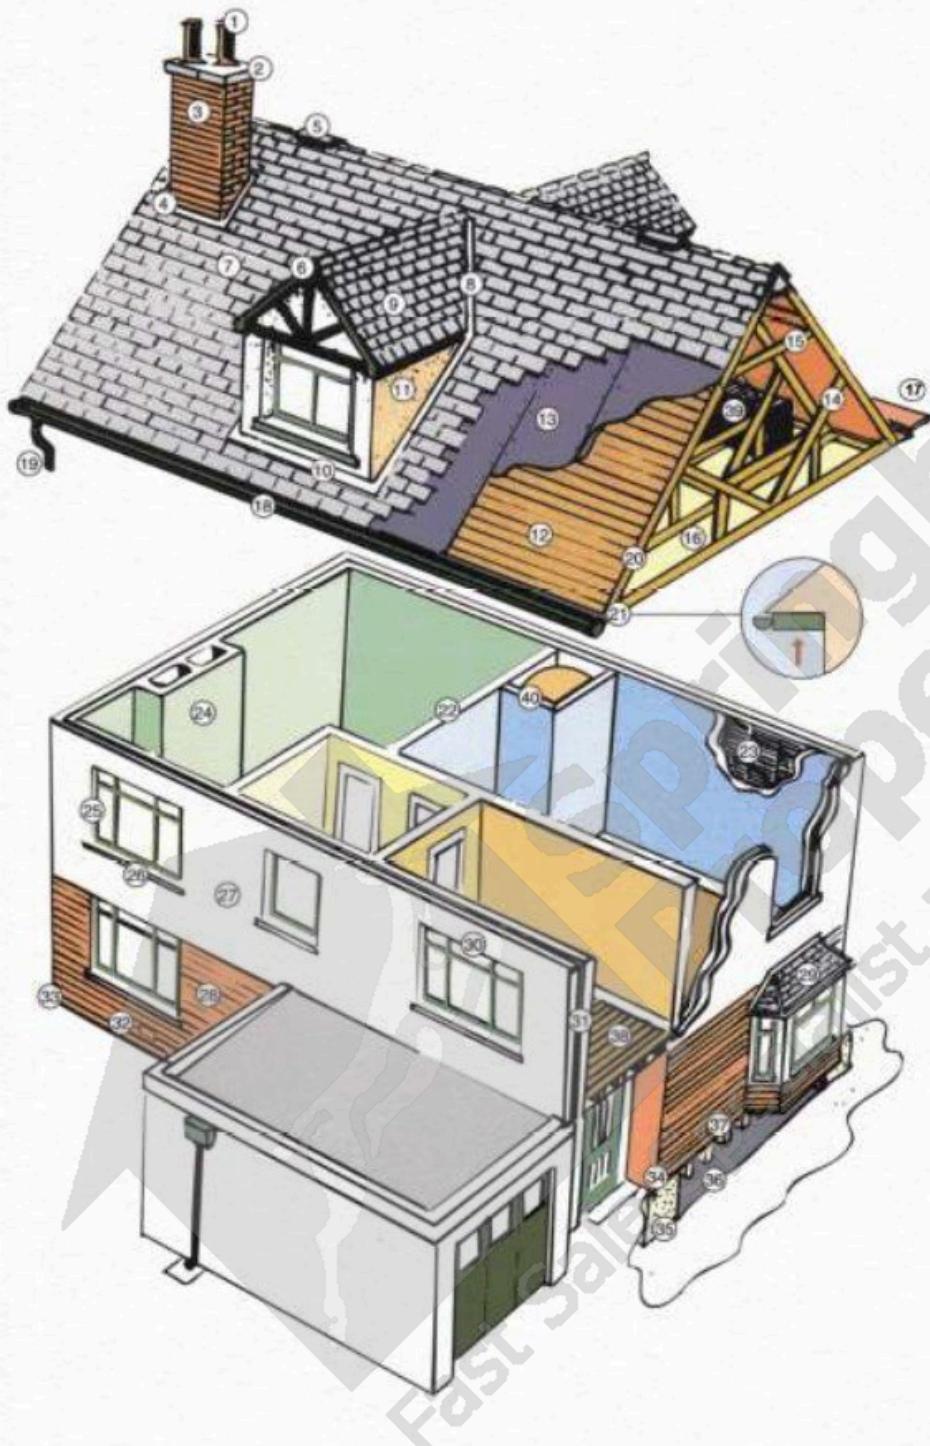
Sectional Diagram showing elements of a typical house

- 1 Chimney pots
- 2 Coping stone
- 3 Chimney head
- 4 Flashing
- 5 Ridge ventilation
- 6 Ridge board
- 7 Slates / tiles
- 8 Valley guttering
- 9 Dormer projection
- 10 Dormer flashing
- 11 Dormer cheeks
- 12 Sarking
- 13 Roof felt
- 14 Trusses
- 15 Collar
- 16 Insulation
- 17 Parapet gutter
- 18 Eaves guttering
- 19 Rainwater downpipe
- 20 Verge boards / skews
- 21 Soffit boards
- 22 Partition wall
- 23 Lath / plaster
- 24 Chimney breast
- 25 Window pointing
- 26 Window sills
- 27 Rendering
- 28 Brickwork / pointing
- 29 Bay window projection
- 30 Lintels
- 31 Cavity walls / wall ties
- 32 Subfloor ventilator
- 33 Damp proof course
- 34 Base course
- 35 Foundations
- 36 Solum
- 37 Floor joists
- 38 Floorboards
- 39 Water tank
- 40 Hot water tank

Reference may be made in this report to some or all of the above component parts of the property. This diagram may assist you in locating and understanding these items.
