Home Report

Scottish Single Survey

Single Survey

Property address	80 Forrestal Street Edzell Woods Brechin DD9 7XG
Customer	Anne-Marie Robb
Customer address	80 Forrestal Street Edzell Woods Brechin DD9 7XG
Prepared by	Shepherd Chartered Surveyors
Date of inspection	13/05/2026

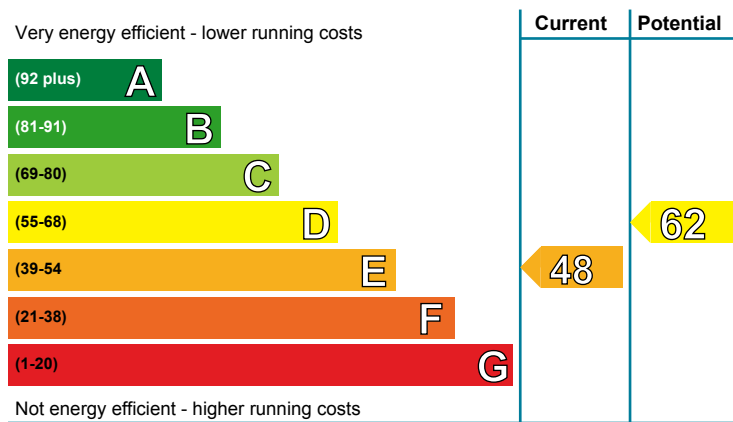
Energy Efficiency Rating

This graph shows the current efficiency of your home, taking into account both energy efficiency and fuel costs. The higher this rating, the lower your fuel bills are likely to be.

Your current rating is **band E (48)**. The average rating for EPCs in Scotland is **band D (61)**.

The potential rating shows the effect of undertaking all of the improvement measures listed within your recommendations report.

Estimated energy costs for your home for 3 years*	£6,432	See your recommendations report for more information
Over 3 years you could save*	£1,251
