Home Report

Single Survey

| Property address | 8c South Campbell Street Paisley PA2 6LR |

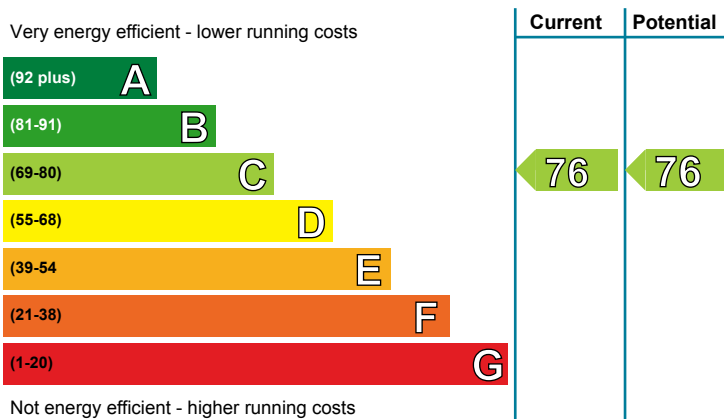
Energy Efficiency Rating

This graph shows the current efficiency of your home, taking into account both energy efficiency and fuel costs. The higher this rating, the lower your fuel bills are likely to be.

Your current rating is **band C (76)**. The average rating for EPCs in Scotland is **band D (61)**.

The potential rating shows the effect of undertaking all of the improvement measures listed within your recommendations report.

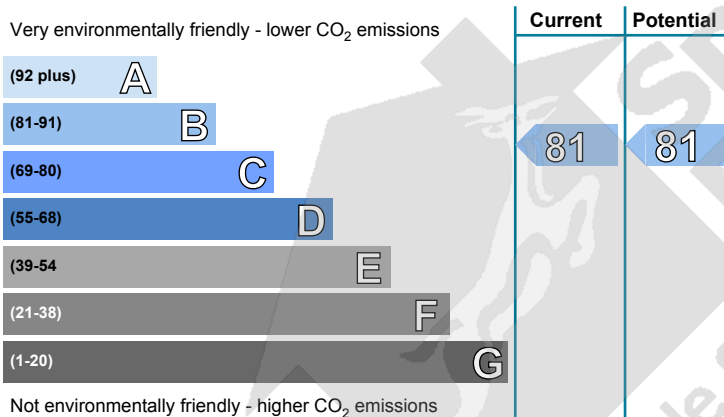
Environmental Impact (CO₂) Rating

This graph shows the effect of your home on the environment in terms of carbon dioxide (CO₂) emissions. The higher the rating, the less impact it has on the environment.
