Home Report

Single Survey

Property address	32 Robertson Drive Elgin IV30 6EU
Customer	[REDACTED]
Customer address	32 Robertson Drive Elgin IV30 6EU
Prepared by	Shepherd Chartered Surveyors
Date of inspection	02/04/2026

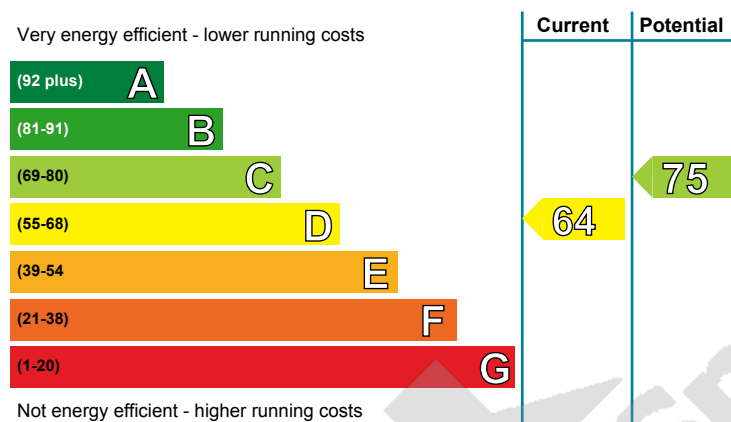
Energy Efficiency Rating

This graph shows the current efficiency of your home, taking into account both energy efficiency and fuel costs. The higher this rating, the lower your fuel bills are likely to be.

Your current rating is **band D (64)**. The average rating for EPCs in Scotland is **band D (61)**.

The potential rating shows the effect of undertaking all of the improvement measures listed within your recommendations report.

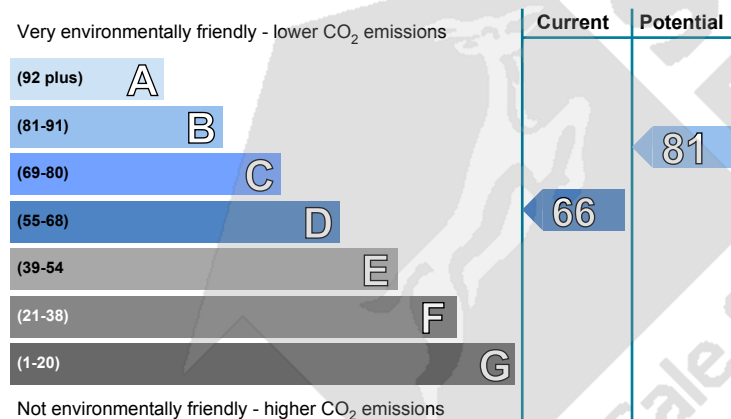
Environmental Impact (CO₂) Rating

This graph shows the effect of your home on the environment in terms of carbon dioxide (CO₂) emissions. The higher the rating, the less impact it has on the environment.
