Home Report

19 Millburn Court,
Inverness,
IV2 3PW

Single Survey

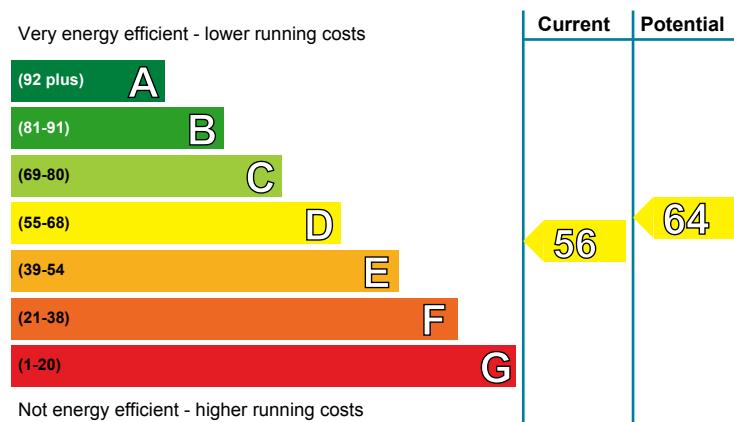
Energy Efficiency Rating

This graph shows the current efficiency of your home, taking into account both energy efficiency and fuel costs. The higher this rating, the lower your fuel bills are likely to be.

Your current rating is **band D (56)**. The average rating for EPCs in Scotland is **band D (61)**.

The potential rating shows the effect of undertaking all of the improvement measures listed within your recommendations report.

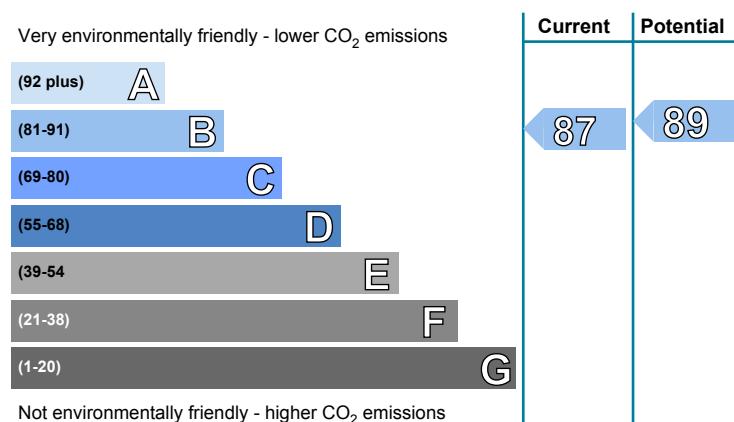
Environmental Impact (CO₂) Rating

This graph shows the effect of your home on the environment in terms of carbon dioxide (CO₂) emissions. The higher the rating, the less impact it has on the environment.
