Home Report

Single Survey

Property address	4 Lawson Street Kilmarnock KA1 3JP
Customer	James Colquhoun
Customer address	4 Lawson Street Kilmarnock KA1 3JP
Prepared by	Shepherd Chartered Surveyors
Date of inspection	21/05/2026

PART 1 - GENERAL

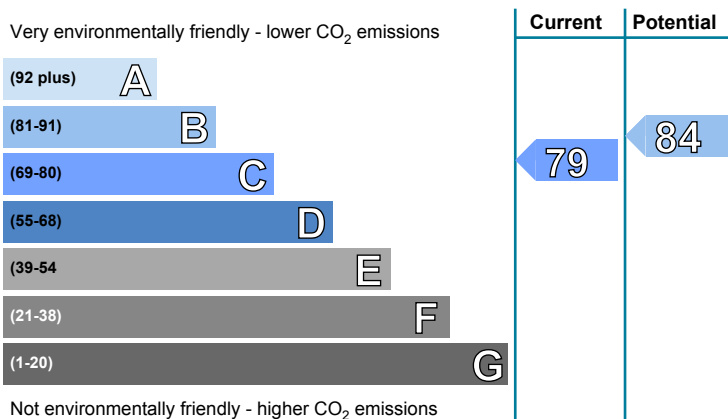
Environmental Impact (CO₂) Rating

This graph shows the effect of your home on the environment in terms of carbon dioxide (CO₂) emissions. The higher the rating, the less impact it has on the environment.
